Wear Behaviour in Acetabular Metal-on-metal Components – Retrieval Analysis

Abstract. The metal-on-metal implants are very low wear articulation systems. In special cases (heavy users - hip abusers), even after the running-in period of about one year in vivo, the wear rate can continue. We analyzed a series of explants, related to revision after traumatic events, at more than three years after initial implantation. The patterns found included large scratches (some millimeters in length and about 5 to 10 micrometers in width and depth) and a wear pattern of the classic polar loaded areas (micro-pits of 1 to 2 microns in diameter). This suggests a possible early failure for these special patients.

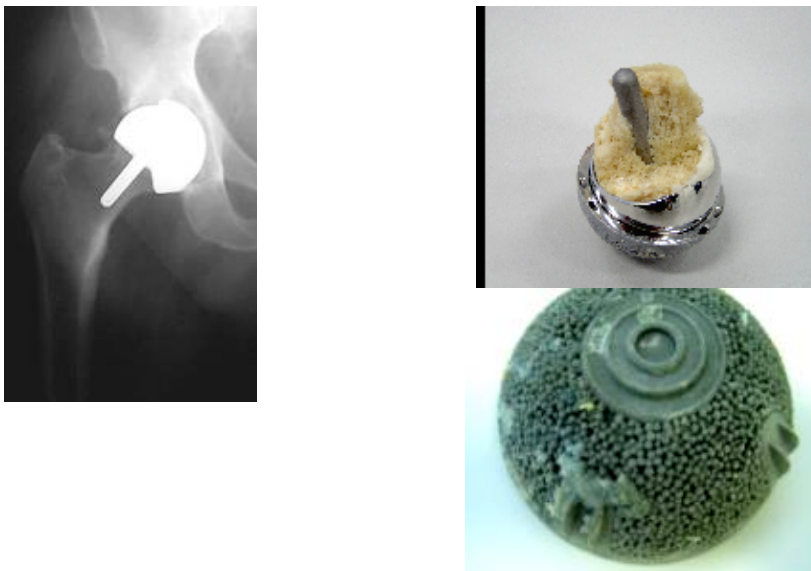
Figure 1 – clinical case: fracture of the femoral neck in a patient with a Birmingham Hip Resurfacing implant at more than 4 years, caused by a 2 meters fall – note the displacement in varus of the acetabular cup. At right, aspect of the explant femoral and acetabular components.

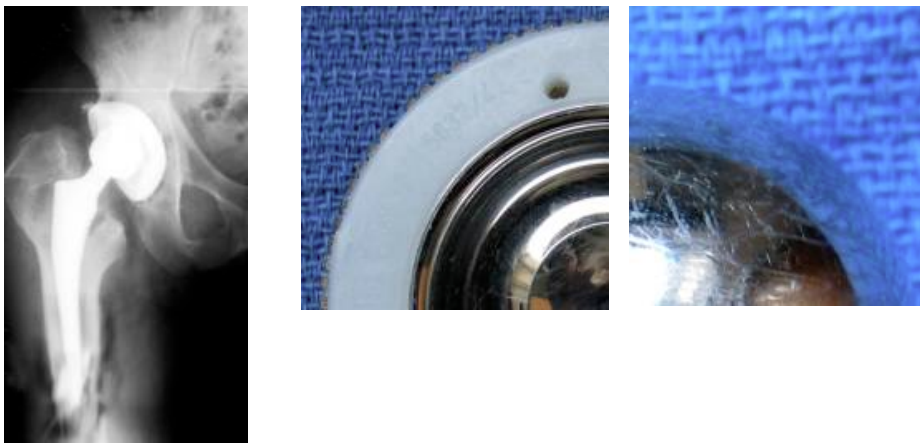
Figure 2 – clinical case: comminuted fracture that occurred distal to the stem tip after high velocity trauma. Both components were loose so revision was necessary. Note the discrete peri-acetabular radiotransparencies. At right aspect of the Allopro – Metasul cup associated to a cementless stem.

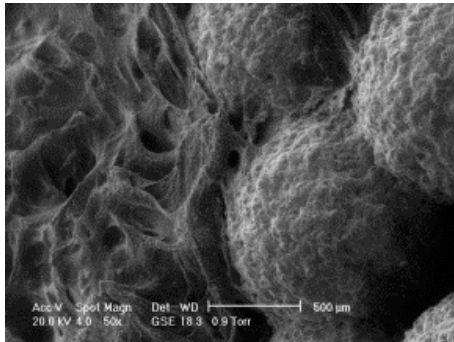
Figure 4 - GSE - Gaseous Secondary Electron Detector imaging of the external surface of the implant. Details of the sintered beads with attached bone tissue - BHR. (50X)

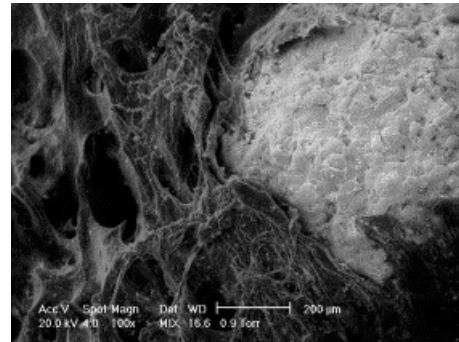
Figure 5 - GSE - The bone tissue (dark areas) in intimate contact with the hydroxyapatite (clear) on the external surface of the retrieved implant – BioMX. (100X)

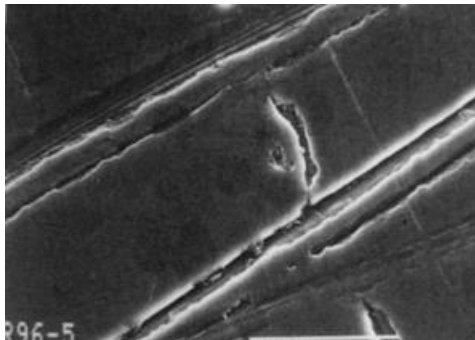
Typical observations included large scratches (some millimeters in length and about 5 to 10 micrometers in width and depth) and a wear pattern of the classic polar loaded areas (micro-pits of 1 to 2 microns in diameter). Image analysis evidenced the last findings on a minimal surface – less than 5% of total bearing area.

Figure 6 - Detailed image - scratches on the Metasul inner surface (5000X)

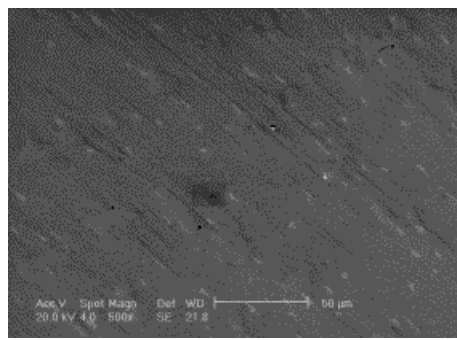
Figure 7 - Detailed image - Micro-pitting on the high stress contact area of the inner surface Metasul implant (500X)

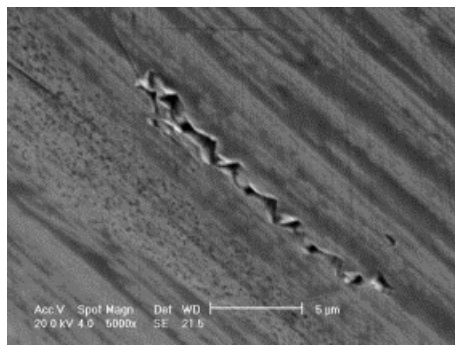
Figure 8 – details of scratches on inner surface of BHR. Area of particles of grit below the scratch. (5000X)

The particles of grit were discovered that were not initially detectable with secondary electron imaging of the original uncorroded surface. That is, probably the grit was found embedded several microns below the implant surface and revealed by ulterior wear. Macrophages filled with metallic particles were found in all tissues analysed at revision time, but in larger amounts in those with metallosis.

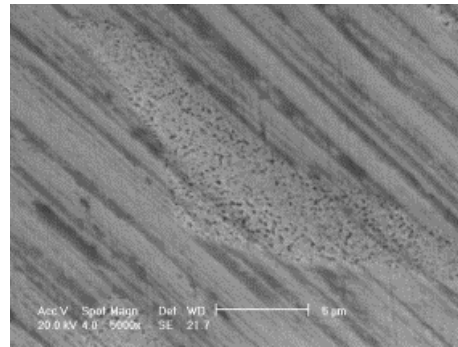
Figure 9 – micro-pitting areas observed on inner surface of BHR – sometimes in association with scratches as seen in figure 8
