FATIGUE FAILURE OF CENTRIFUGAL BOMB AXIS

In this work it is carried out a fracture analysis of a centrifugal bomb axis used in petrochemical industry, by using techniques such as SEM fractography, microstructural observation of duplex stainless steel in an optical microscope and hardness tests. These techniques complement each other and thus, in an efficient way they allow the identification of the cause of the component failure.

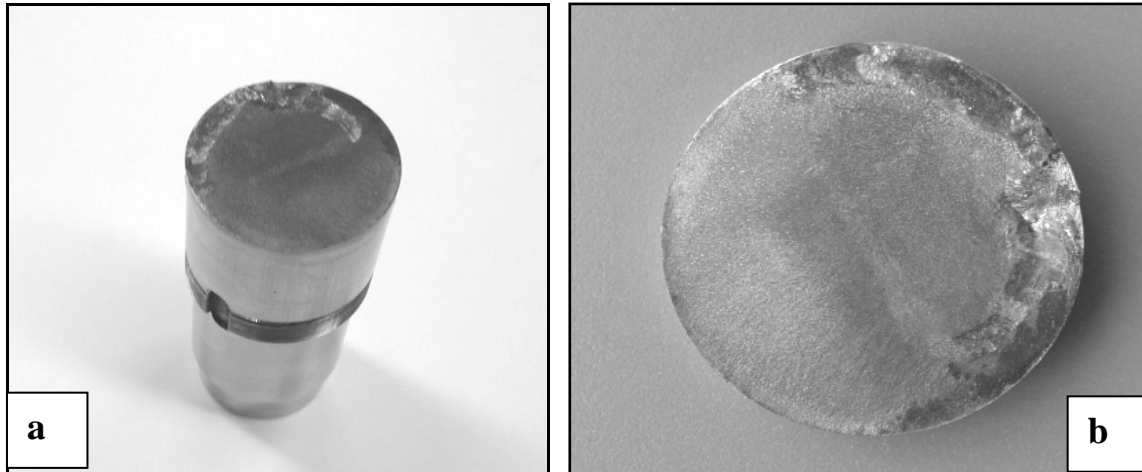
Figure 1a shows the fractured centrifugal bomb axis as received, while figure 1b, obtained in a stereo-microscope, presents the macroscopic overview of the fracture surface. Figure 2 shows the microstructure of the duplex stainless steel, with austenite delineated in a ferritic matrix, which is in accordance to the NACE/ISO standard (NACE MR0175 / ISO 15156-3, 2003). Through optical microscopy it was not found σ phase. Figure 3, obtained in a scanning electron microscope (SEM), presents detailed aspects of the fracture surface, in which striations are clearly visible. These striations indicate failure by fatigue of the material (Metals Handbook, 1986). Figure 4 shows detailed aspects of other regions of the same fracture surface. Table 2 shows results of Rockwell C hardness test.

Figure 1. (a) Fractured centrifugal bomb axis (b) Fracture surface: macroscopic overview.

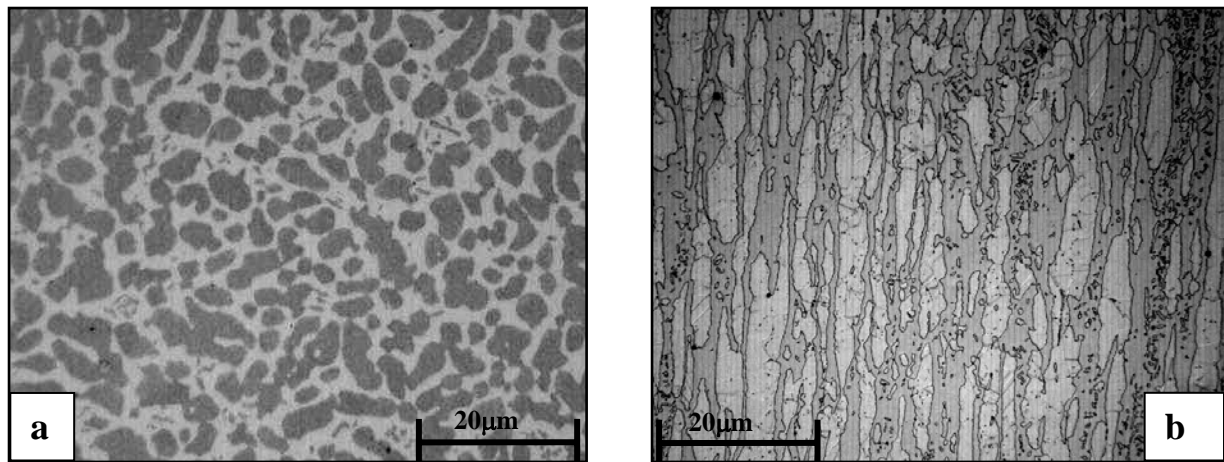
Figure 2. Duplex stainless steel microstructure: (a) transverse section; (b) longitudinal section.

- Microstructure, composed by austenite in a ferritic matrix, which is in accordance to the standard, and no σ phase was observed in optical microscope.
- The hardness of the duplex stainless steel sample (22.4 HRC) also meets the specified values (lower than 25 HRC).
- There is no evidence of corrosion neither any other kind of degradation in the material.
- SEM images reveal evident presence of fatigue striations on the fracture surface.

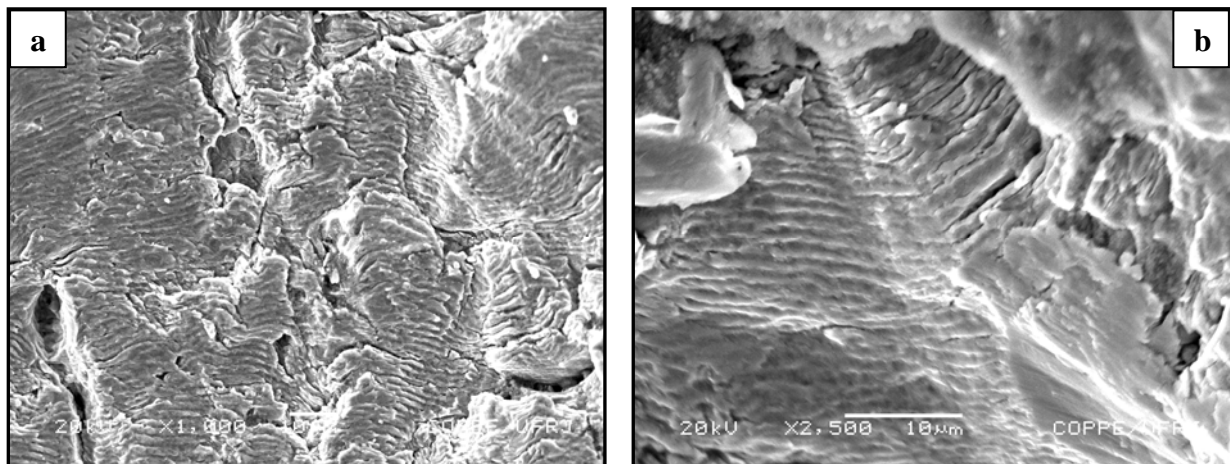
Figure 3. SEM images: (a) Fracture surface presenting fatigue striations. (b) Detailed aspect of the same region.

The previous results suggest that the fatigue failure was probably caused by misalignment during the assembly of the equipment.

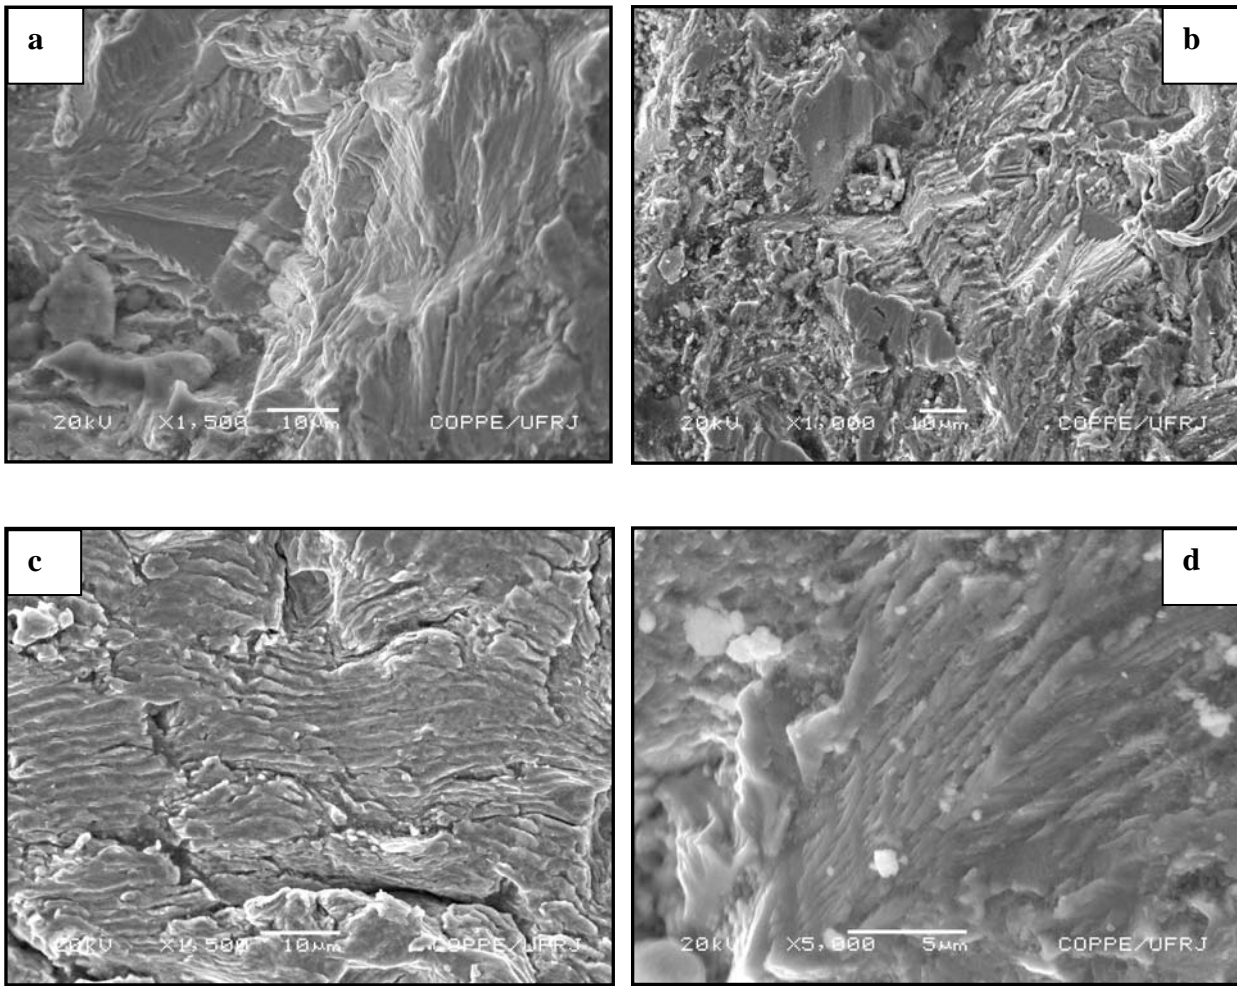
Figure 4. (a) ,(b), (c), (d) Detailed aspects of other regions of the same fracture surface
