DEVELOPMENT OF A GAMMAGRAPHY SYSTEM FOR UNDERWATER PIPELINES INSPECTION

The inspections were executed in three pipelines located in the Campos Basin, corresponding lines PVM1-PVM2, PVM2-PVM3 and PVM3-PPG1. The pipelines are made of steel and have thicknesses of approximately 11 mm. The depth in the implementation of the work was about 80 m. Images were obtained from seven different spots and the exposure times were adjusted for each spot, due to the passage or not of oil inside the pipeline at the moment of radiography. Table 1 shows the diameters of each line and the exposure time used in each spot. The activity of Ir-192 source was 2.15 TBq and the focal spot size was 2.95 mm.

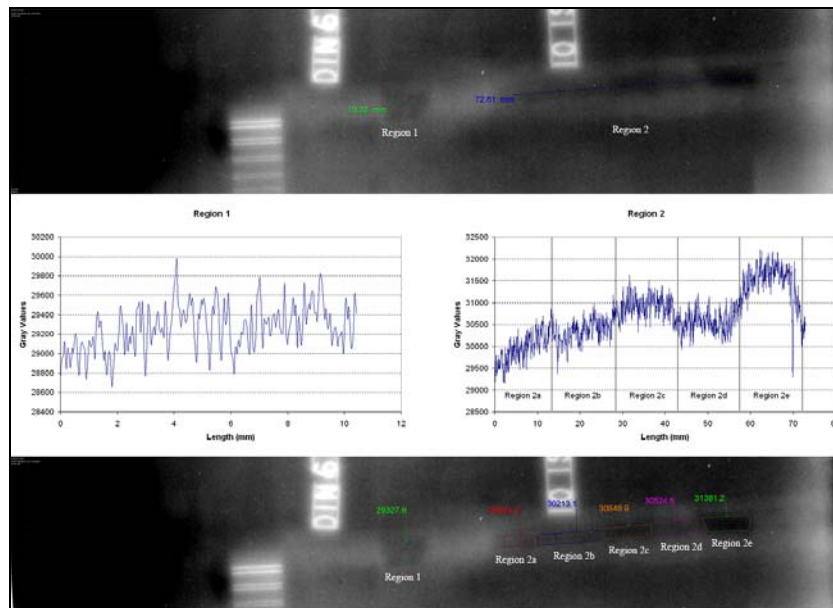
Figure 5. Image and analysis of the spot 1.

Table 3. Wall loss value determined by the methods of interpolation and effective absorption coefficient for the spot 1.

Wall Loss (%)		
	Interpolation	Effective Absorption Coefficient
Region 1		
a	8.50	8.31
Region 2		
a	10.25	10.72
b	13.73	14.66
c	17.48	18.59
d	15.56	16.48
e	20.62	22.54

The corrosion displayed more punctual occurrence in the welded joints of spots 1, 2 and 6 and more uniform in spots 3, 4, 5 and 7, but, with regions of greater relative loss of thickness in all cases.

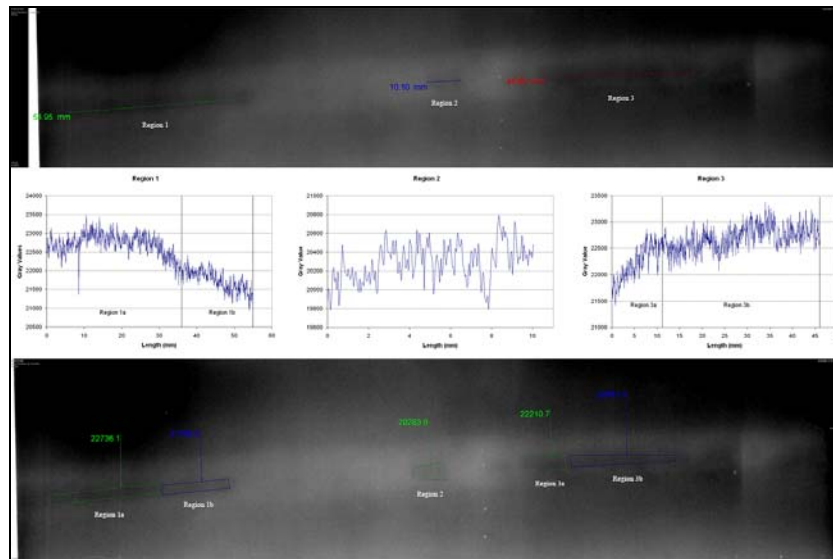
Figure 6. Image and analysis of the spot 2.

Table 4. Wall loss value determined by the methods of interpolation and effective absorption coefficient for the spot 2.

Wall Loss (%)		
	Interpolation	Effective Absorption Coefficient
Region 1		
a	24.63	24.64
b	15.61	16.31
Region 2		
a	1.82	1.83
Region 3		
a	19.74	19.50
b	23.65	23.95

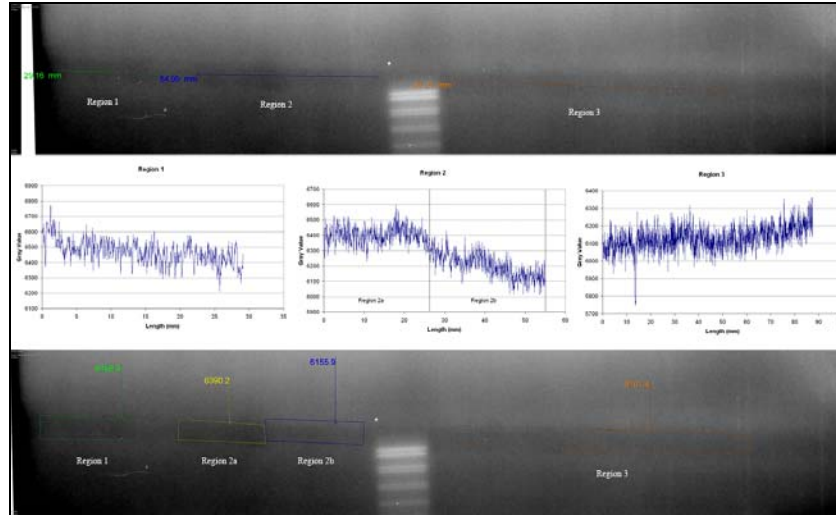
Figure 7. Image and analysis of the spot 3.

Table 5. Wall loss value determined by the methods of interpolation and effective absorption coefficient for the spot 3.

Wall Loss (%)		
	Interpolation	Effective Absorption Coefficient
Region 1		
a	26.80	28.20
Region 2		
a	24.57	26.82
b	16.67	16.88
Region 3		
a	14.84	12.87

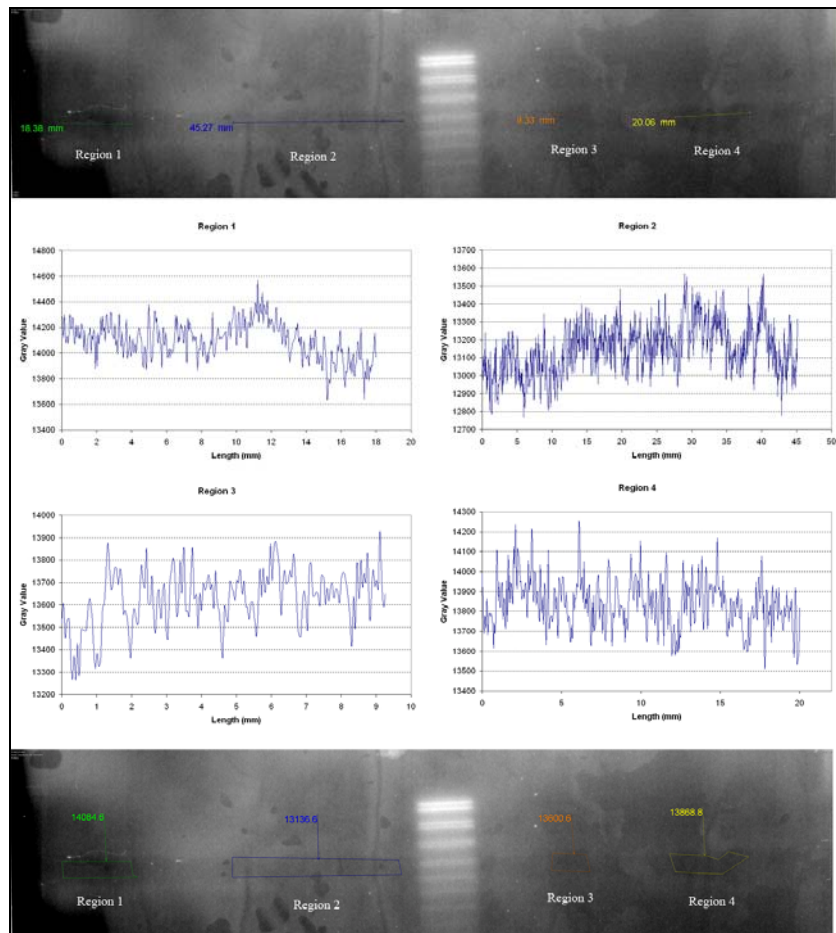
Figure 8. Image and analysis of the spot 4.

Table 6. Wall loss value determined by the methods of interpolation and effective absorption coefficient for the spot 4.

Wall Loss (%)		
	Interpolation	Effective Absorption Coefficient
Region 1		
	26.12	28.34
Region 2		
	11.52	10.02
Region 3		
	18.67	18.16
Region 4		
	22.80	24.18

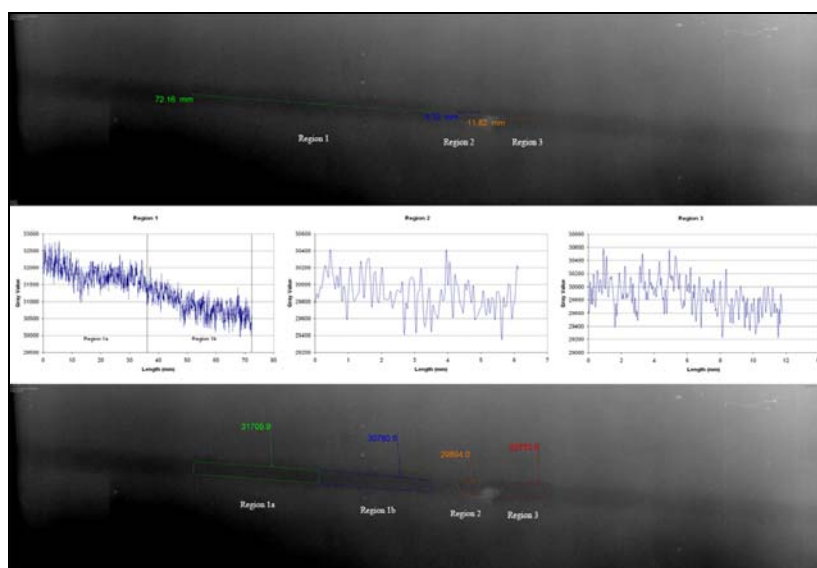
Figure 9. Image and analysis of the spot 5.

Table 7. Wall loss value determined by the methods of interpolation and effective absorption coefficient for the spot 5.

Wall Loss (%)		
	Interpolation	Effective Absorption Coefficient
Region 1		
a	9.68	10.85
b	8.15	10.24
Region 2		
a	9.59	11.34
Region 3		
a	8.37	10.29

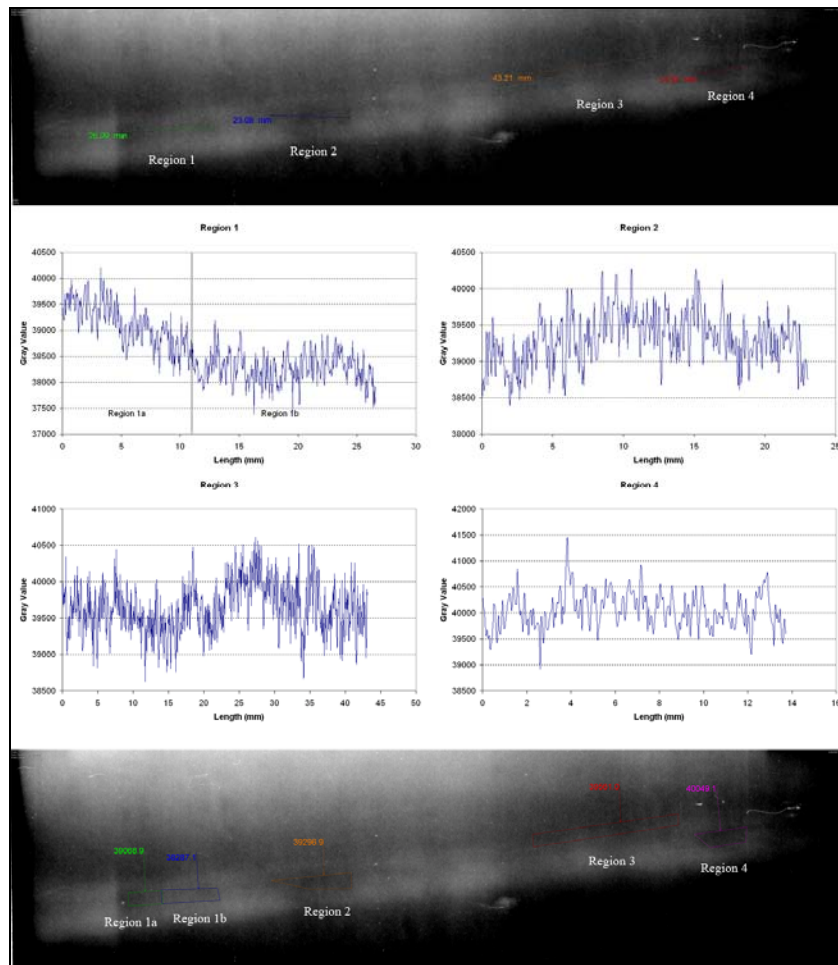
Figure 10. Image and analysis of the spot 6.

Table 8. Wall loss value determined by the methods of interpolation and effective absorption coefficient for the spot 6.

Wall Loss (%)		
	Interpolation	Effective Absorption Coefficient
Region 1		
a	16.13	16.03
b	11.21	11.41
Region 2		
a	17.57	16.97
Region 3		
a	19.23	18.79
Region 4		
a	22.31	23.65

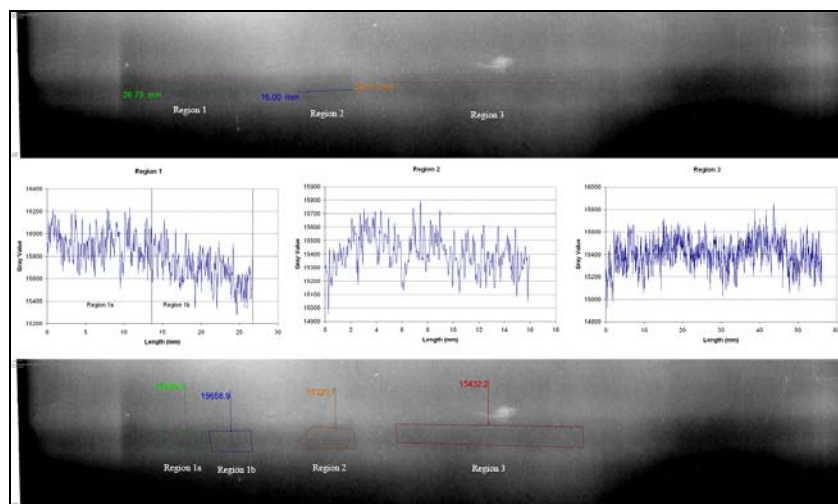
Figure 11. Image and analysis of the spot 7.

Table 9. Wall loss value determined by the methods of interpolation and effective absorption coefficient for the spot 7.

Wall Loss (%)		
	Interpolation	Effective Absorption Coefficient
Region 1		
a	21.59	24.90
b	17.42	18.10
Region 2		
a	11.57	13.67
Region 3		
a	13.50	16.91
