FAILURE CASE ANALYSIS – EFFECT OF ENFORCED DISPLACEMENT IN SHEAR TIE COMPONENTS

EMBRAER – Empresa Brasileira de Aeronáutica S/A – VPI/DTE/GEE Av. Brig. Faria Lima, 2.170 – São José dos Campos – SP
rudnei.wittmann@embraer.com.br

Abstract. This work presents the investigation of failures occurred in Shear Tie components at the Full Scale Fatigue Testing. Local instrumentations were made with use of Strain Gages and LVDTs in order to measure local stresses and displacements. A refined F.E. model was made to check the hypotheses made and to try a solution approach. A Plane Strain F. E. M. study was carried on in order to find the crack nucleation location. A Fractographic analysis has presented the crack initiation points. Based on all these studies, it has been concluded that the crack has occurred due to a cyclic enforced displacement. Then a new design solution has been found and a dedicated experimental testing program took place. Small representative shear ties were subjected to cyclic enforced displacement in a separate testing set up. First the test had reproduced original shear tie failures. Then the solution design was tested and the result had confirmed that this new compon

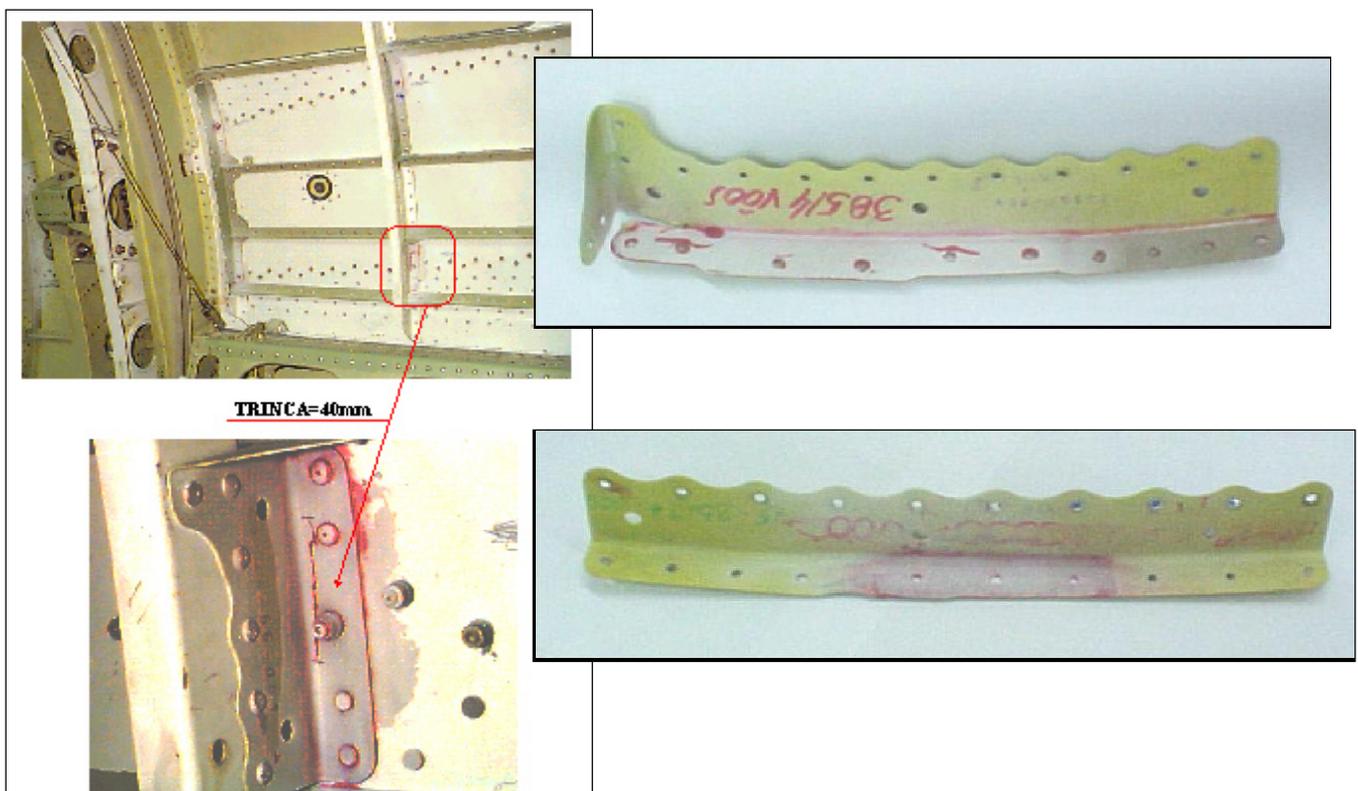
Figure 1: Crack found in a Shear Tie component at the Full Scale Fatigue Testing.

The cracks were detected at the first time with 15000 flight cycles, which means approximately 8 years of aircraft normal operation. The crack at these components initiates at the flange, just behind the commented Hi Lite and it propagates transversely to the shear tie following the flange direction. As usual, all the failed components have been replaced by new ones, and the airplane continued to fly. Cracks had recursively happened in the same place following a nucleation time of approximate 15000 flight cycles.

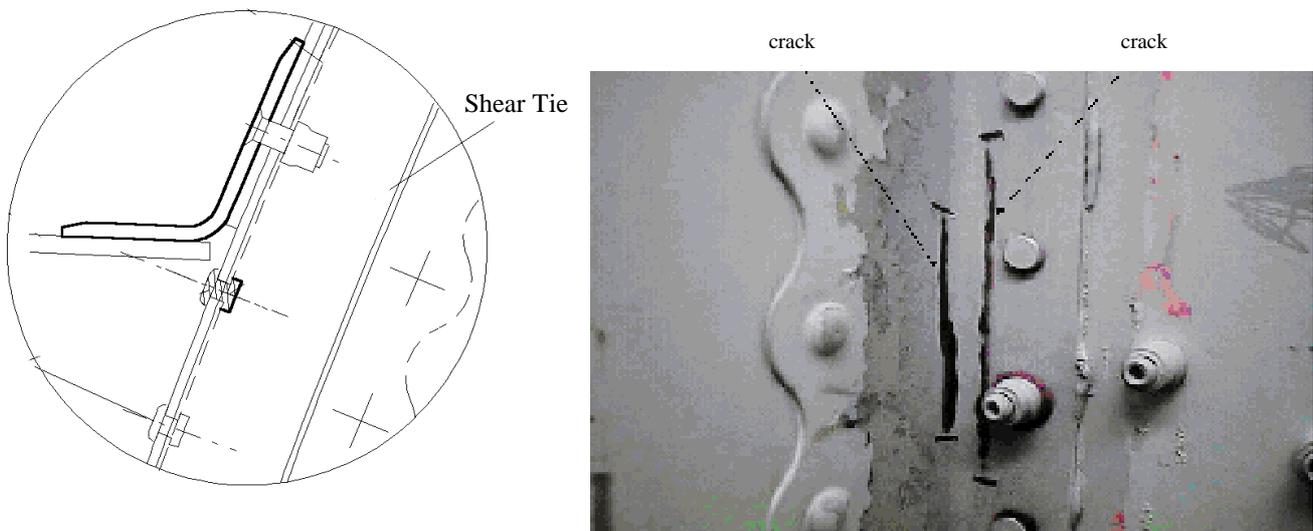
In drawings observation it was verified that the shear tie is connected to an external rigid "L" by means of that specific Hi Lite where the crack surges (Fig. 2). Then it was observed that could be possible the existence of some load deriving from that external "L" and coming inside to pull the shear tie, imposing to it a enforced displacement.

Figure 2: Hi Lite installation at the shear tie.

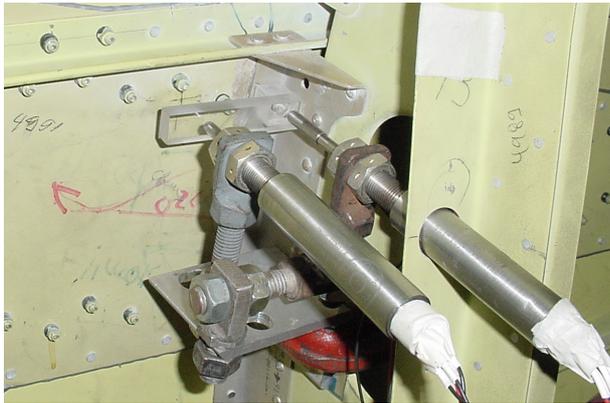
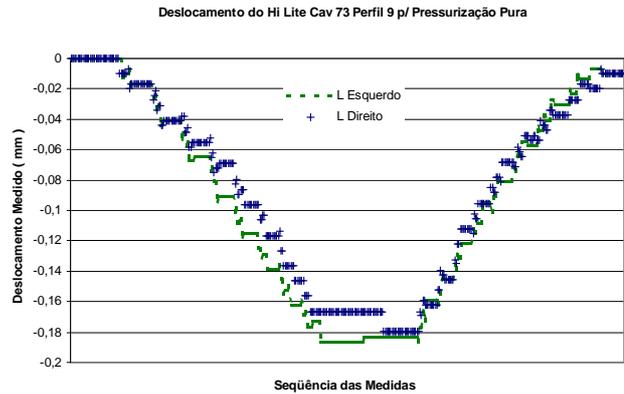
The LVDT instrumentation installed at the shear clip Hi Lite can be seen in Figure 3 and has the objective of measure the Normal-to-Skin displacement of the Hi Lite. The LVDT fixity was done at the adjacent frame. Once it is possible to occur some small angle movement with the frame, then 2 LVDTs were installed in line from the frame, in order to capture this movement. Then it is possible to separate the two components obtaining the pure axial movement of the Hi Lite.

Figure 3: LVDTs instrumentation at the Shear Tie Hi Lite and typical result for pressurization.

- The displacement in Hi Lite happens mainly due to the external “L” movement at the Normal-to-Skin direction;
- The displacement for a flight type 7 is approximately 0,38mm ;
- The displacement for a flight type 5 is approximately 0.41mm .

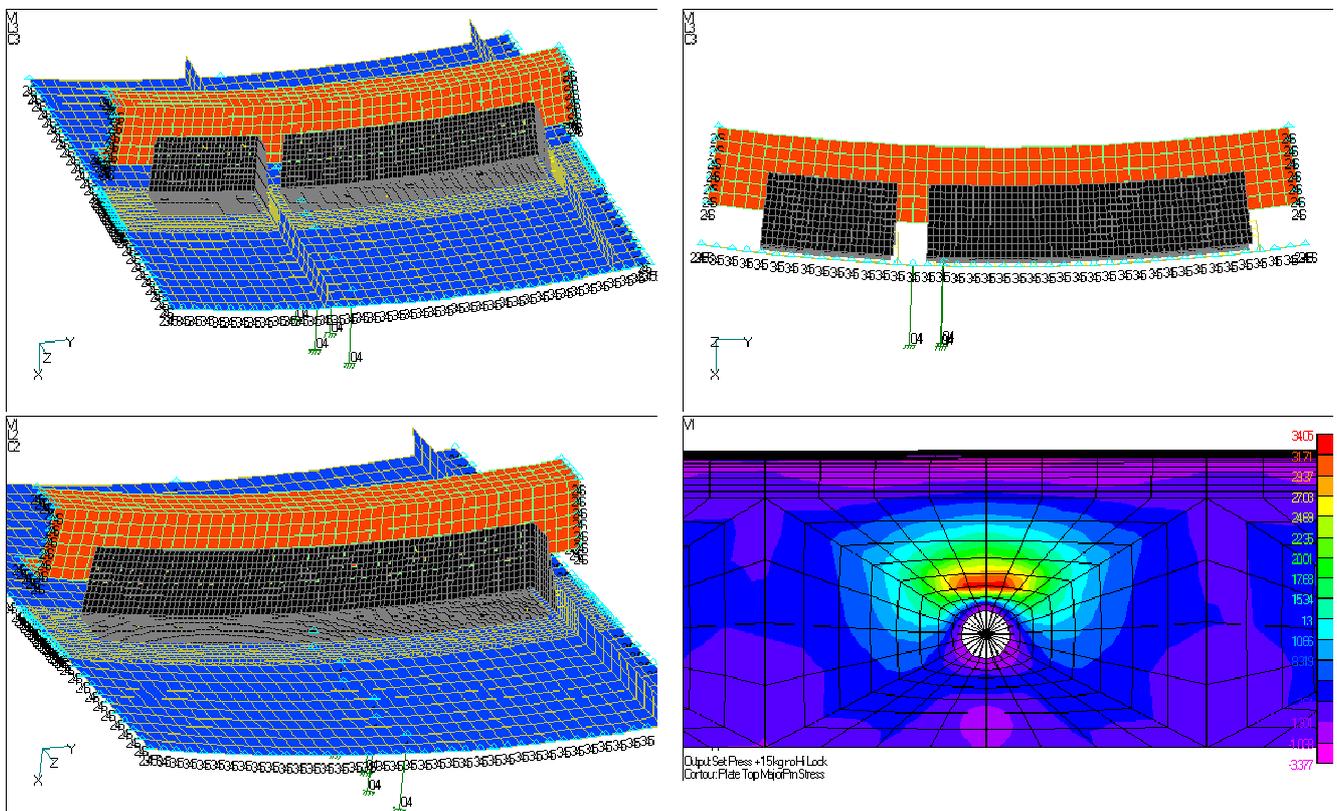
After some trials, it was found that, with the value of a enforced displacement $d = 0.4 \text{ mm}$ applied to the Hi Lite position, the stress obtained is $\sigma_D = 34 \text{ kgf/mm}^2$, see Fig. (4). Then this is the value of enforced displacement we were looking for. Realize that this value ($d = 0.4 \text{ mm}$) is exactly the same obtained from the LVDT instrumentation procedure.

Figure 4 : Mesh visualization of the FEM used and Shear Tie maximum stress position and value obtained.

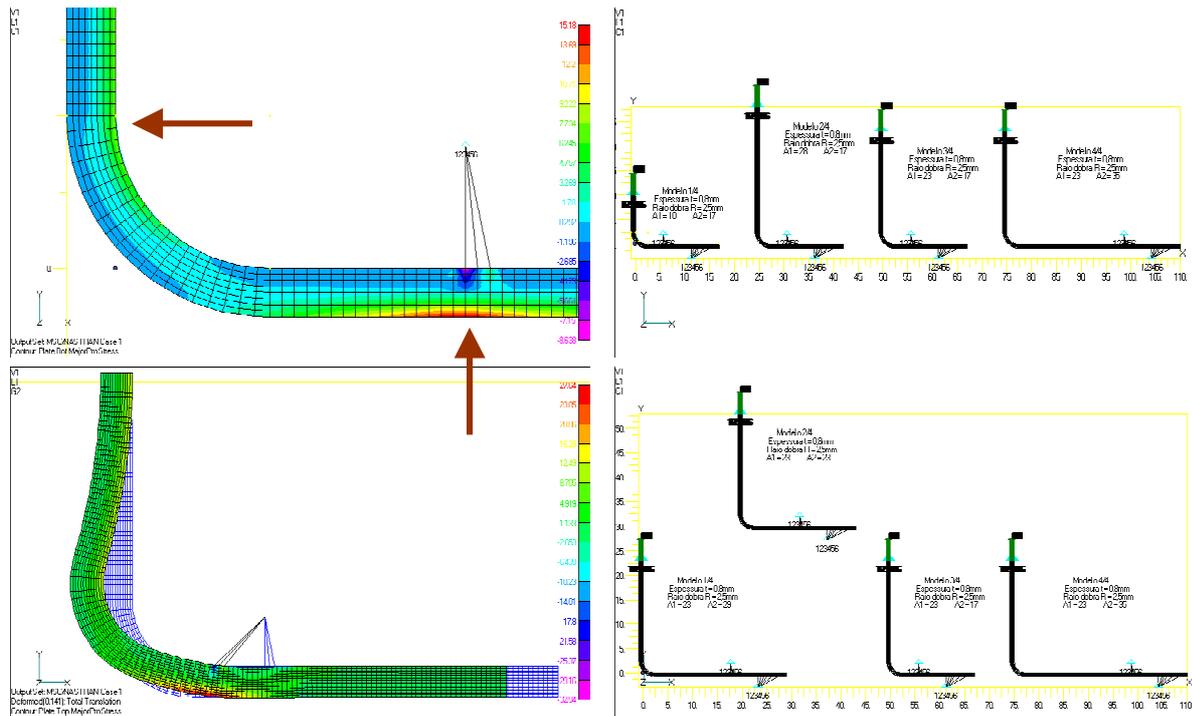
In this study it was verified that the maximum stress region is located at the bottom side of the shear tie, exactly below and tangentially at the Hi Lite head, and after that, there exist another high stress region exactly at the final of the bend radius at the upper side of the shear tie - see Fig. (5).

After that, some parameters have been changed to check the influence of the thickness, the fastener position, and the frame attachment variations on the stress results. And with this approach, it was verified that an improving of the shear tie rigidity do not contribute to decrease the involved stresses, but exactly the opposite happens. Then the solution approach seems to be an improving of the flexibility or, in other words, to decrease the stiffness of the component.

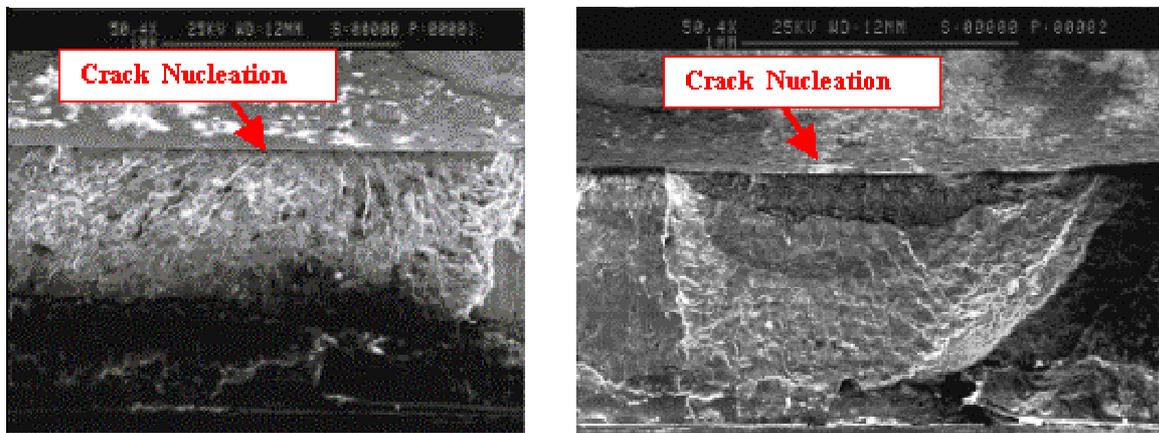
The Fractographic analysis that was made at these components has the objective of locate the actual points of crack initiation for all the cracks found at these components (Fig. 6). The results show that all the crack near the Hi Lite had initiated at the bottom (inner) side and all the crack at the bent region had initiated at the top (outer) side – Fig.(7). And these are truly the same locations as what were predicted by the theoretical plane strain approach.

Figure 6 : Fractographic Analysis Results – MEV View

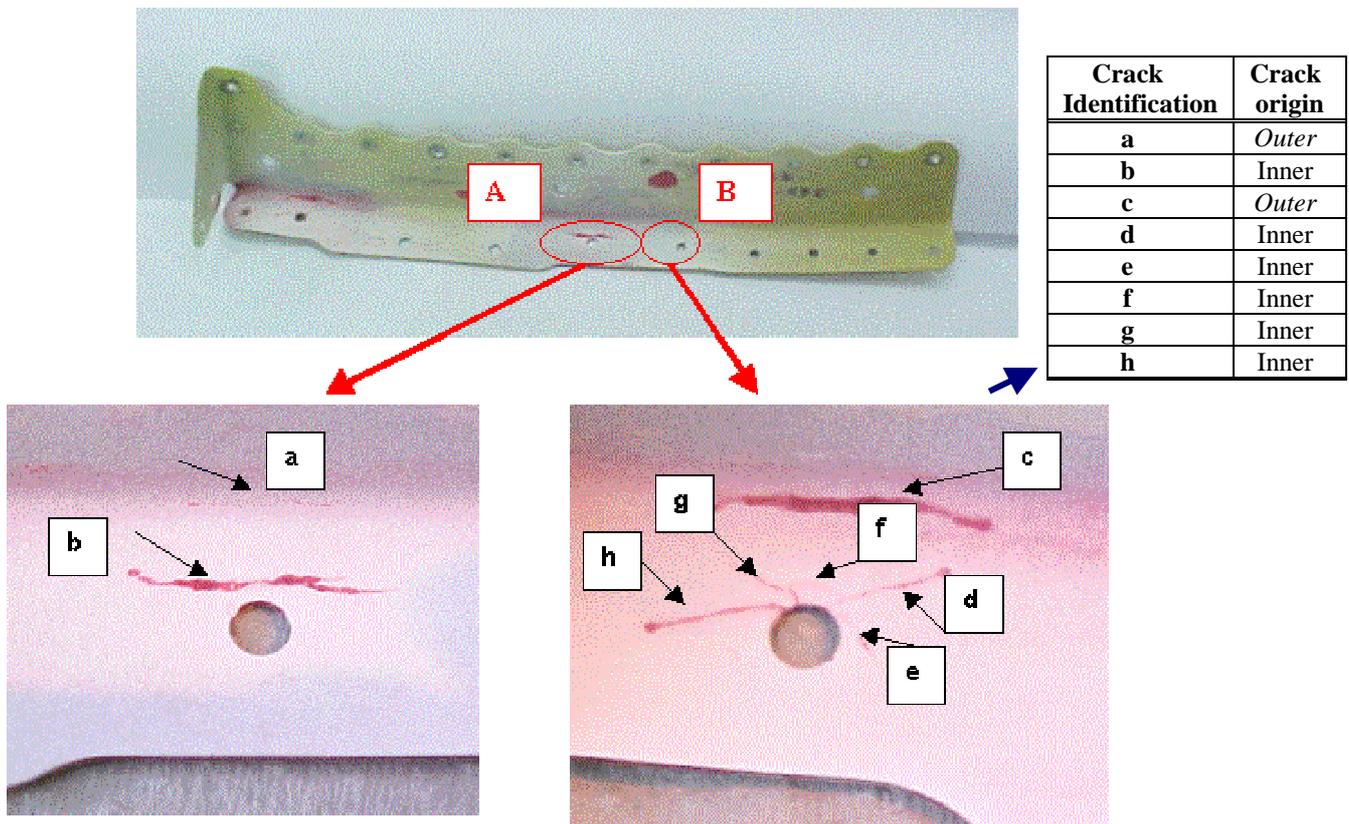
Figure 7 : Fractographic Analysis Results

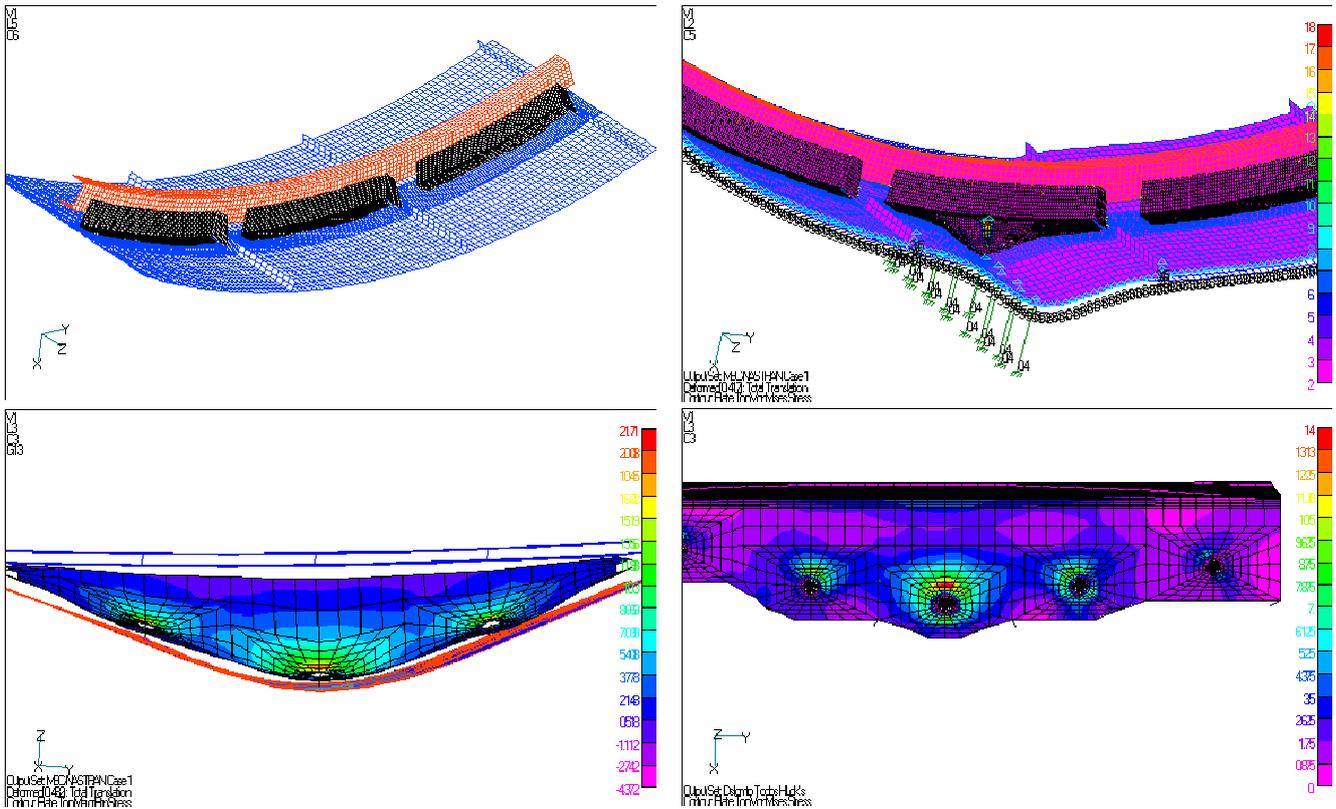
Figure 8 : Visualization of the FE Model simulating the solution.

Using a FE detailed model and with a trial and error approach a new geometry solution has been found for the shear ties. It involves put the fasteners step by step increasing its distance from the web. It can be seen at Figure 8.

The final solution has been found moving the Hi Lite and its two each side fasteners neighbors to a new position far away from the web. The new distances are: 13mm / 17mm / 20mm / 17mm / 13mm . The Hi Lite distance from the web needs to be 20mm , and its firsts neighbors need to stay stepped little by little until reaching the standard value of the fasteners distance to the web, ~ 10mm.

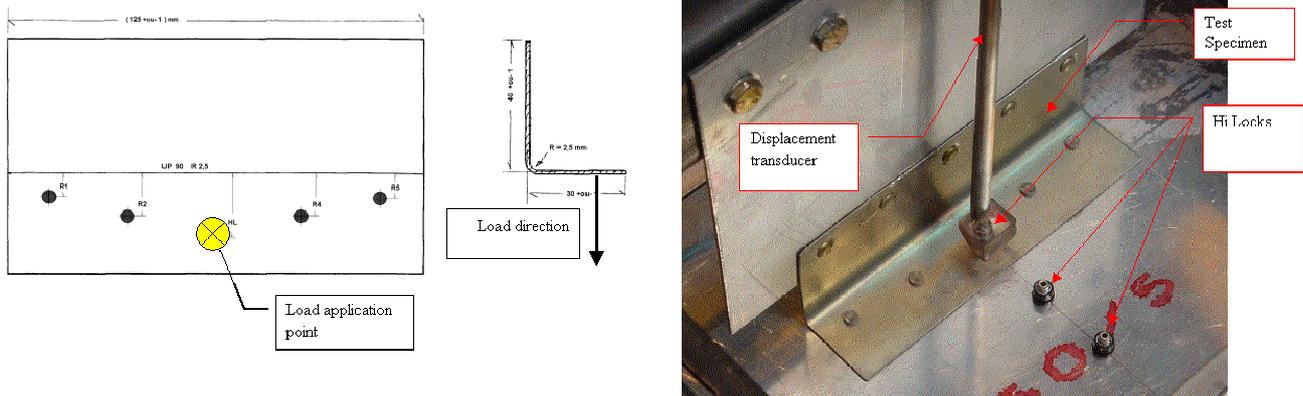
First the test had reproduced shear tie cracks exactly at the same location and same number of cycles of the crack found at the Full Scale Fatigue Testing. Three shear ties with standard distance ($d = 10\text{mm}$) were tested by applying a cyclic enforced displacement and they had cracked at 12 000 cycles (medium).

Then the solution design was tested and the result had confirmed that this new component design can safely operate during an entire life of the airplane. Three shear ties with the new geometry were tested by applying a cyclic enforced displacement and they had cracked after 100 000 cycles.

Figure 9: Experimental Testing Set-Up
