RESULTS OF THE INFRARED THERMOGRAPHY AND LASER DOPPLER VIBROMETRY APPLICATION IN THE DIAGNOSTIC OF STRUCTURAL PATHOLOGIES IN MONASTERIES OF ROMANIA

Keywords: *Infrared thermography, laser Doppler vibrometry, structural diagnostic, medieval monasteries of Moldavia*

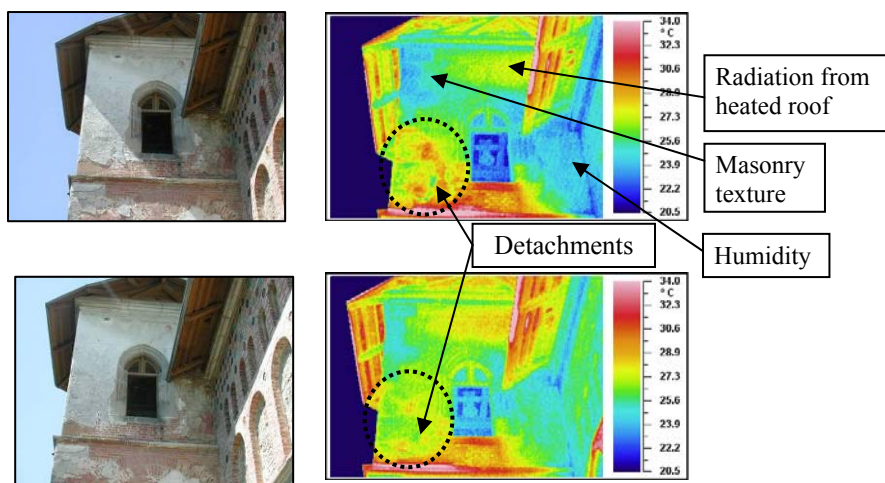
Figura 6. San Nicholas Church (Bălinești) – entrance portal (sector superior east)

The thermographic studies in the Church of San Nicholas have been initiated in the east sector of the entrance portal. The images were taken in two moments. The results obtained for the superior area can be seen in Fig.6. The photos identify the analyzed area and the conditions of shadowed in the moment in which the thermal image was registered. The pathologies found are related.

The humidity presence, characterized by areas of low temperatures, has been identified in the regions next to the walls junction. This occurrence is very frequent and here it is favored by the vegetation presence that reduces the arrival of direct solar radiation. For the restorers, the identification of these points has been interesting once that the occurrence is reflected in the interior side of the wall, favoring the frescoes detachments that, currently, are in initial process of restoration. Although simple, the diagnostic was decisive for the adoption of preservation actions in that sector.

Beyond the humidity, it could be identified the presence of some detachments in specific points of the plaster used for the wall recovery. Some structural characteristics could be identified, as masonry bricks and the stones used as base for the vertex.

An area with high temperatures has been identified in the superior part of the construction. However, this occurrence has no relation with detachments; it is originated by solar reflections from the roof, constituted of metal plates (typical in the region architecture).

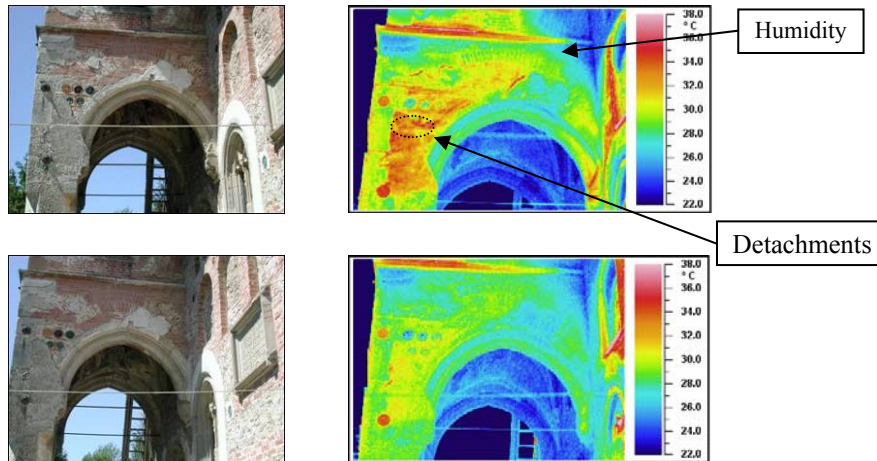
Figura 7. San Nicholas Church (Bălinești) – entrance portal (sector inferior east)

It can be observed that the humidity presence continues in the inferior sector, in regions next to the walls junction. It has been identified some detachments in the areas re-covered by plaster, beyond the basic structure of rocks. This identification has been possible due to the lower conductivity of the rocks that delayed its process of heating, resulting in colder points in the thermal image.

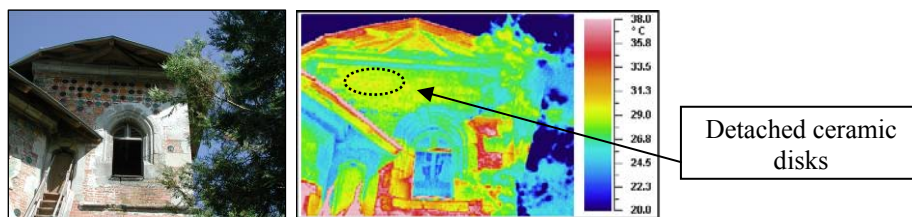
Figura 8. San Nicholas Church (Bălinești) – entrance portal (sector superior west)

It has been possible to identify some points of high temperatures in the west superior sector of entrance portal, related to ceramic disks that began to detach from the structure. It can be seen in Fig. 8.

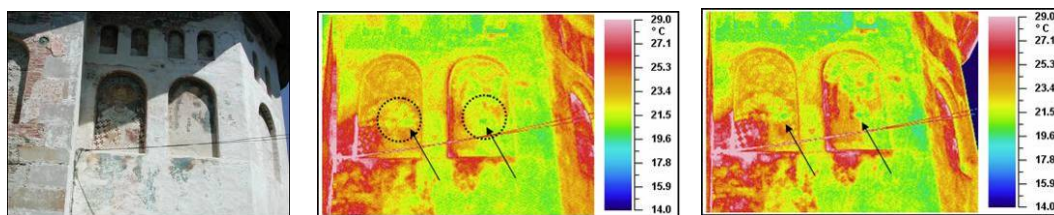
Figura 9. San Nicholas Church (Bălinești) – frescoes (south sector)

In the remaining frescoes located in the south sector of the church, a small area with a non-identified material used in a previous restore has been identified by the IRT. There was no information about it in the historical documents or in the restoration reports. The thermal conductivity of this material made possible its identification by IRT. Chemical analyses will be done in order to identify the characteristics of the used resin. Figure 9 shows these occurrences.

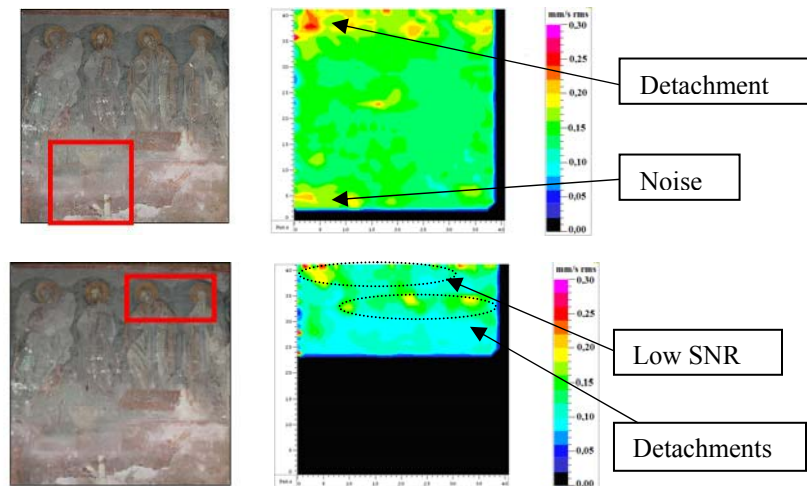
Figure 10. San Nicholas Church (Bălinești) – fresco (entrance atrium – east wall)

With the objective to identify detachments, SLDV has been implemented in the internal frescoes of the entrance atrium. Figure 10 presents the evaluated areas of a fresco located in the east wall of the entrance atrium. The results have been presented in form of RMS maps where the pathologies found are also related.

SLDV has identified consolidated areas and areas with detachments of the layers that compose the frescoes. The detachments have come characterized in the RMS map by high speed of vibration. Some areas have presented low signal-noise relation, which has rendered difficult the analysis. During the tests the transit of people over the wooden floor where has been placed the vibrometer generated a signal that could be configure false alarm of irregularity. The occurrence of this type of measurement noise could represent a problem to the SLDV implementation in places of elevated visitation; it does not occur with the IRT. On the other hand, the detachments have been identified, even in areas where low signal-noise relation existed.

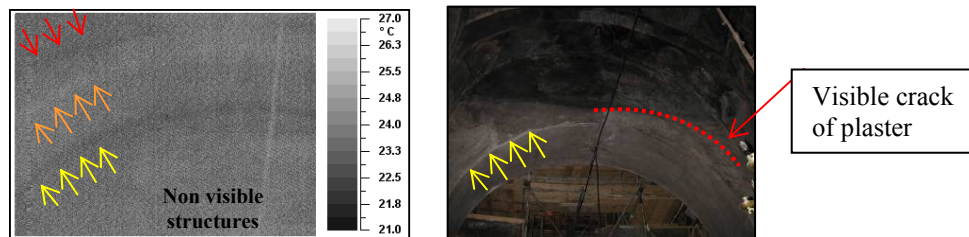
Figure 11. Church of Popăuți Monastery (Botoșani) – narthex arch

The thermographic studies in the Church of the Popăuți Monastery have identified structural alterations effected during interventions realized, throughout the time, in the wall that divides the narthex of the aisle. Figure 11 presents the analysis realized in that sector.

In the arch that divides the narthex of the aisle was possible to identify a visible line of crack. The IRT has identified not only this visible crack, but it has also indicated that the crack was continuing, although no visible, in the opposite side of the arch. This crack is the result of a registered previous reform, which enlarged the arch, before of small dimension. The IRT has identified a second line of crack; probably result of a previous non-registered reform, which, once more, enlarged the arch dimensions. This information has been important to the restorers in order to prevent other cracks, especially because the restorative works of the frescoes placed in the internal part of the arch has already concluded.

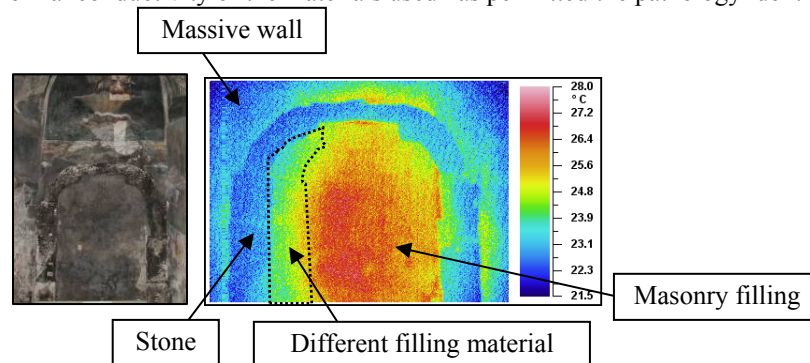
Figure 12. Church of Popăuți Monastery (Botoșani) – old narthex entrance

Originally, the main entrance of the church was situated in the north sector of narthex. In reform carried out at the beginning of century XX, this entrance has been substituted by another one, located in the south direction (Sinigalia e Vetros, 2006). The IRT application has permitted identifying the diverse materials used to close the door, as seen in Fig. 12. Once more, the thermal conductivity of the materials used has permitted the pathology identification.

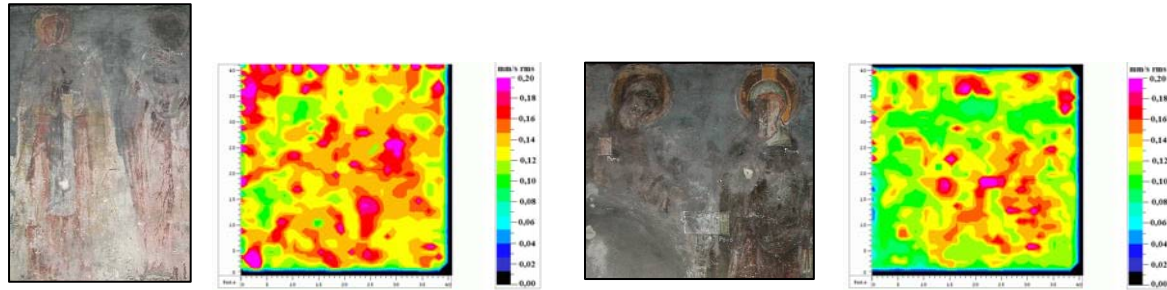
Figura 13. Church of Popăuți Monastery (Botoșani) – frescoes of the narthex

The SLDV has been used in the diagnostic of the frescoes. It confirmed the problems already pointed by the restorers: presence of great areas of detachments, which can cause the total loss of the paintings. The RMS maps obtained for two frescoes are presented in Fig. 13 and confirm this information: large areas of high speed of vibration, related to the detachments, have been located.

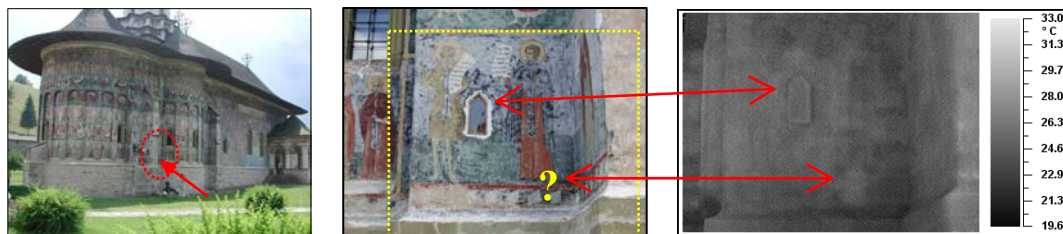
Figure 14. Church of Resurrection (Sucevița Monastery) – frescoes of north wall

The thermographic tests have been realized outside of the Church of the Sucevița Monastery and have revealed non-visible structures, not identified by other techniques or by the restorers. The most interesting pathology has been found under the frescoes of the north wall, in an area analyzed by SLDV. The IRT has identified a small window that was filled by masonry material, this one different of the original material (the thermal properties of the fulfilling material enabled the identification of the pathology by IRT). This occurrence has called the attention of the restorers. There was no information about it in the historical documents or in the reports of anterior restorations. On the other hand, nothing has been identified by the SLDV. The restorers believe that it could be an execution error, which has been corrected during the church construction or later, during some non-registered reform. This because the location of the small windows is extremely symmetrical throughout the all construction; this fulfilling window is completely out of this symmetry. The thermographic image that identified the hidden window and local photos can be seen in Fig. 14.

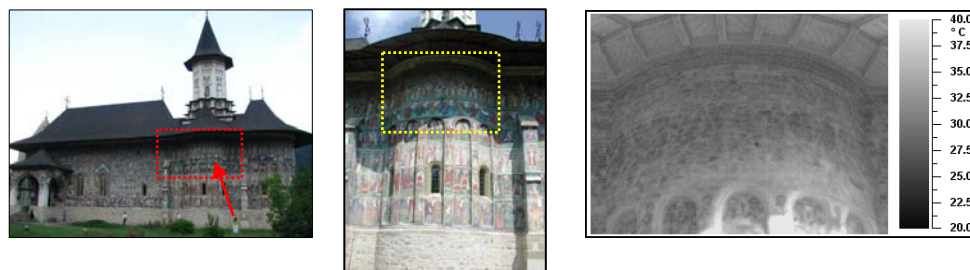
Figura 15. Church of Resurrection (Sucevița Monastery) – south wall

The IRT has been applied to the south wall where has identified the bricks of masonry that constitute the first layer of the frescoes structure. Figure 15 presents these results.

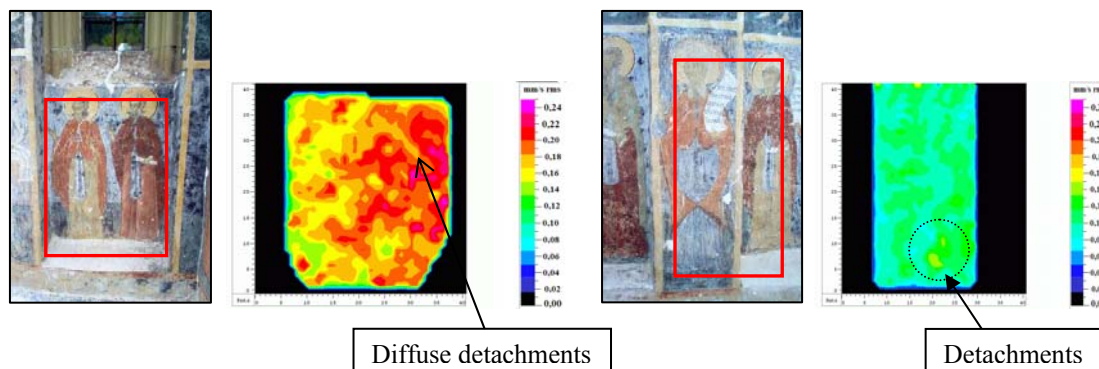
Figura 16. Church of Resurrection (Sucevița Monastery) – frescoes of north wall evaluated by SLDV

The outer frescoes are a characteristic of the Moldavian architecture. However, as in the Church of Resurrection, they are exposed to meteorological conditions, what increase the damages. In order to evaluate the actual state of the outer frescoes of the north wall (recently restored) SLDV has been applied in some of them. In Figure 16 are presented the results obtained and photos of the local, where the testing areas have been delineated.

As can be seen in the RMS maps obtained by the SLDV, a great quantity of detachments has been identified in the outer frescoes of the north wall.

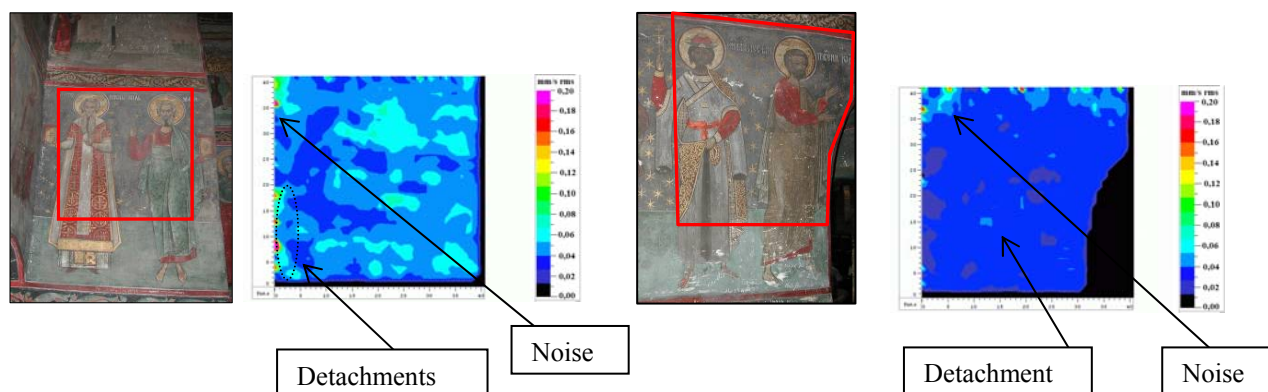
Figura 17. Church of Resurrection (Sucevița Monastery) – indoor frescoes evaluated by SLDV

The analyzed internal frescoes have presented good conditions of conservation: just few detachments, of minimum dimensions, have been found. By other side, some problems, related to low Doppler signal, have been evidenced. They have been caused by the presence of measurement noises. The results obtained by accomplishment of the SLDV on the frescoes placed in the mortuary chamber can be seen in Fig. 17.
