THE SPECIFICATION FOR THE QUALIFICATION OF THE AFT COVER FIXATION SCREW OF THE SATELLITES LAUNCH VEHICLE VLS-1 ENGINES

Being the application in subject, its took place a study to specify and to accomplish assays for qualification of the screw of head six-sided, wrought and laminate, " rolled " thread, type M14x1,5x28,5 mm, used for the fixation of the Back Cover of the metallic rocket engines of VLS 1, made in steel of high resistance AISI 4340, martensitic of low league, which supplies advantageous resistance combinations, ductility and toughness for several applications.

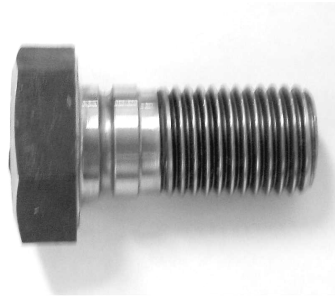
The “Figure 2” shows the aspect and the geometry of the screw that has the following characteristics:

Material: AISI 4340 high strength alloy steel

Tensile strength - $\sigma_t = 1200$ MPa

Hardness in the nucleus: 37 a 40 RHC

Diameter 14 mm

Thread M14x1,5x28,5 mm.

Figure 2. technical drawing of the screw

The screw has a channel that allows to place a o'ring to avoid a possible pressure losses due to a gas leakage during the operation of the rocket engine propellant burn.

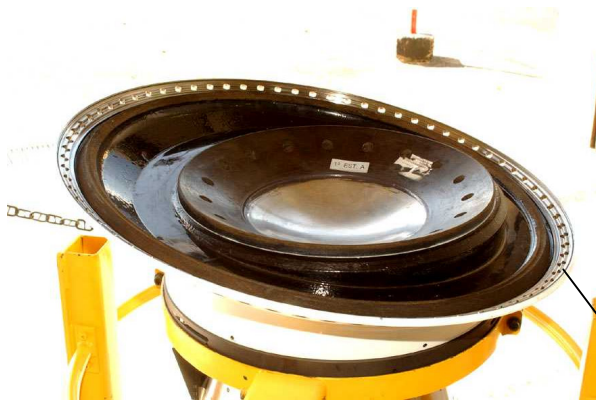
The Figures 3 and 4, shows the details of the area of application of the screw and of the mounted aft cover and fixed one of the metallic rocket engines of VLS 1.

Figure 3. Screw application area
