INFRARED THERMOGRAFIC INVESTIGATION OF BASILICA DELLA SALUTE FLOOR

***Abstract.** The infrared thermography applied to cultural and monumental goods diagnostic is one of more consolidated non-invasive techniques used actually. Its popularity is mainly due to its capacity to indentify non visible faults, humidity and others normal occurrences in works of art. In this work the experimental results obtained through the infrared thermography implementation on samples of the Basilica della Salute (Venice – Italy) floor are presented. The experimental procedures have been carried out using active thermography where the artificial heating has been obtained through the use of tungsten lamps. The thermal analysis allowed to identify restoration operations due to materials used which have different origin of the base material and, consequently, different thermal diffusivity and emissivity. The influence of the superficial color over the results is also discussed.*

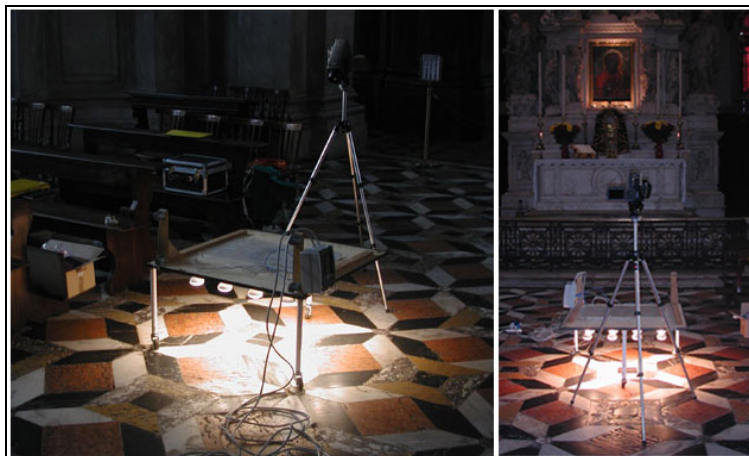
Figure 5. Thermographic bench

The heating system has been placed horizontally and in parallel with the floor. After the period of heating, the lamps panel has been moved and started the data acquisition. The bench can be seen in Fig. 5.

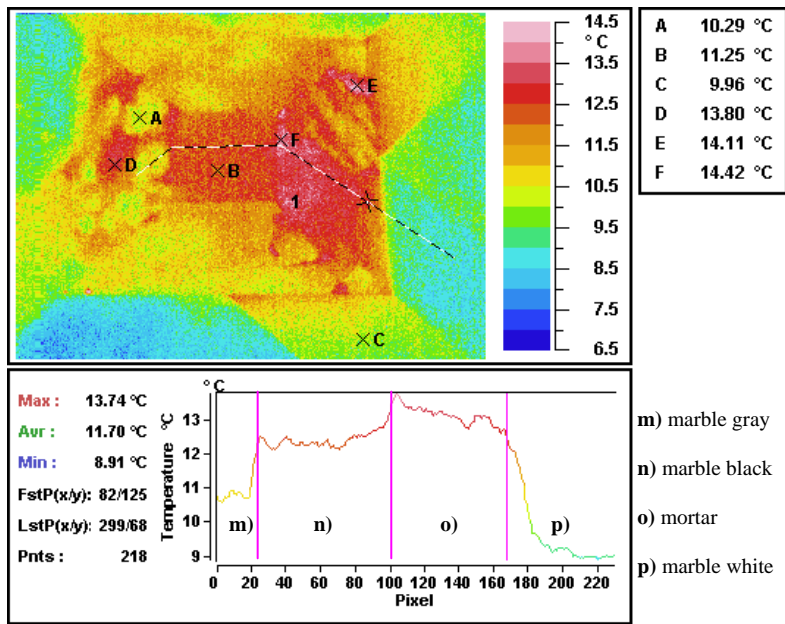
Figure 8. Punctual temperatures and profile temperature of sample 1

In Figure 8 has been shown some punctual temperatures of the thermal image and the temperature profile in a longitudinal portion of the sample section. The choice of the place within the thermographic image for analysis of the temperature profile has been made so that such profile presented spots coinciding with the diverse materials presents on the sample. The image corresponds to the moment of maximum thermal contrast.

In Figure 8 the relative temperatures to the points A, B and C, that oscillate around $10\text{-}11^{\circ}\text{C}$, are those ones attributable to elements in marble. The point A corresponds to the light brown marble, the B point to the square of black marble placed in the center of the sample, and the point C to the white marble. The highest level of temperature has been registered in the point C and the lowest in the point A. These differences of temperature are once more inside of the thermal camera uncertainty of measurement. So, the color effect is no significant.

If the average temperatures on the portions which contains marble are equal to $10,5^{\circ}\text{C}$, it can be estimated that the temperatures of the others three points (D, E and F), which present average values equal to 14°C , are attributed to the presence of a different material. This association is only possible due to the temperature difference between these points that are greater than the measurement uncertainty. The temperature differences between the several areas restored with mortar are, probably, due to the different kinds of mortar used or due to its thickness changeable. Another hypothesis to be evaluated is the presence of non visible detachments.
