## SEM OBSERVATIONS AND ELECTROCHEMICAL BEHAVIOUR OF A STAINLESS STEEL IMPLANT DEVICE - A CASE STUDY

**Keywords:** *corrosion resistance, stainless steel F138, internal fixation plate*

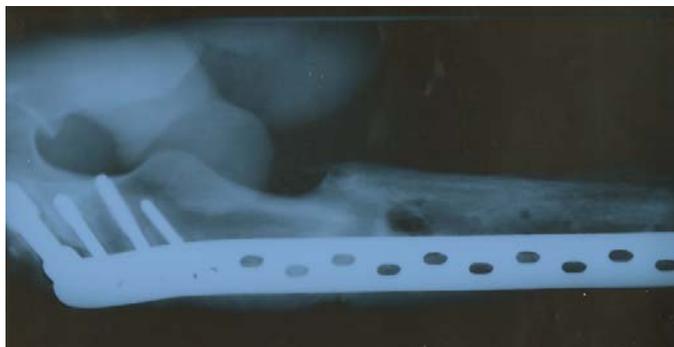
Figure 1 shows a partial radiograph of the implanted plate attached to the femur of the patient.

Figure 1. Radiograph of the implanted stainless steel F138 plate before removal from the patient.

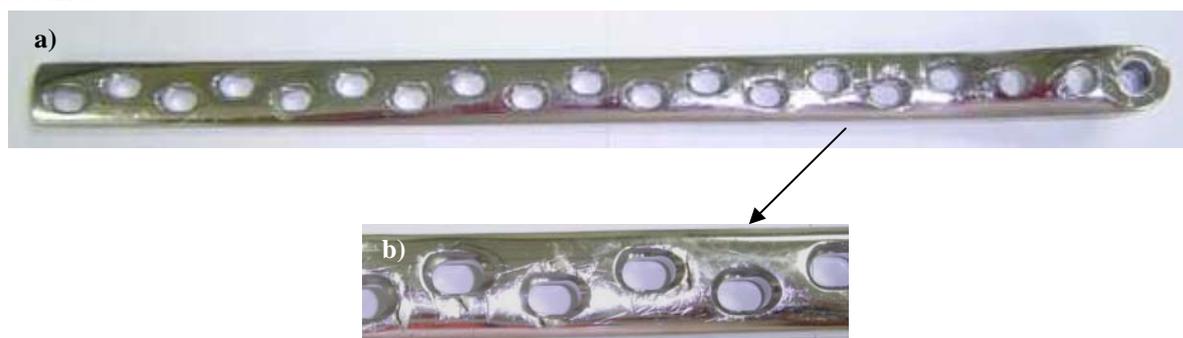
The plate removed from a patient after 26 months is shown in Fig. 2a. There are visible signs of mechanical deformation on the right side of the plate that may have been introduced during the implantation or the removal from the patient. These signs are shown in detail in Fig. 2b. On the other hand there were no visible signs of corrosion on the plate surface.

Figure 2. Photograph of the stainless steel plate after removal from the patient: (a) Overview of the entire piece; (b) Detail of the right side of the piece showing several risks.
