Wear Behaviour in Acetabular Metal-on-metal Components – Retrieval Analysis

Abstract. The metal-on-metal implants are very low wear articulation systems. In special cases (heavy users - hip abusers), even after the running-in period of about one year in vivo, the wear rate can continue. We analyzed a series of explants, related to revision after traumatic events, at more than three years after initial implantation. The patterns found included large scratches (some millimeters in length and about 5 to 10 micrometers in width and depth) and a wear pattern of the classic polar loaded areas (micro-pits of 1 to 2 microns in diameter). This suggests a possible early failure for these special patients.

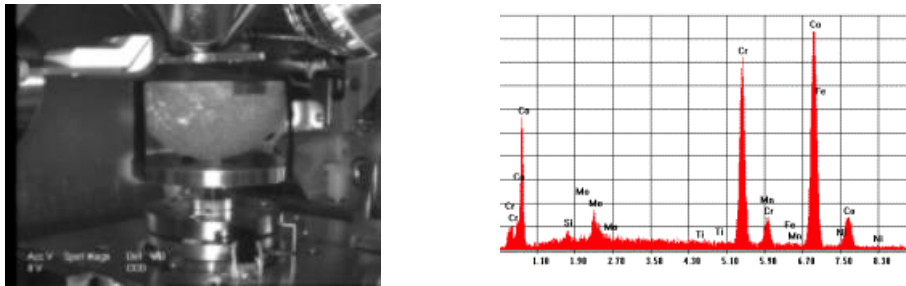
Figure 3 – the explanted cup positioned in the examination chamber. Probes underwent morphologic ESEM examination and photography with primary magnifications of 50X, 100X, 1000X and 5,000X, 1 Torr pressure, at 20kV and 10 to 22 mm WD . At right – the spectrum of alloys utilized in the implants was very similar.
