RESULTS OF THE INFRARED THERMOGRAPHY AND LASER DOPPLER VIBROMETRY APPLICATION IN THE DIAGNOSTIC OF STRUCTURAL PATHOLOGIES IN MONASTERIES OF ROMANIA

Keywords: *Infrared thermography, laser Doppler vibrometry, structural diagnostic, medieval monasteries of Moldavia*

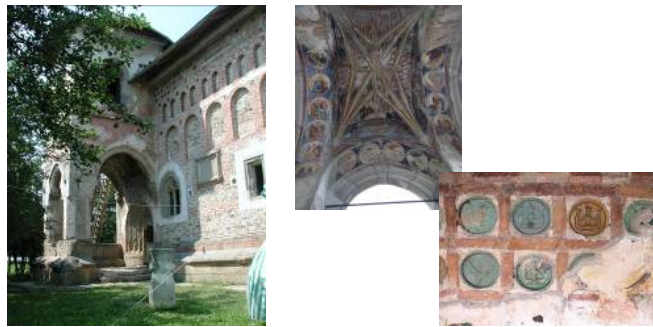
The IRT has been used, in its passive form (Tavares *et al.* 2006), for the evaluation of the conservation state of the external masonry of the entrance portal. It allowed identifying humidity and detachments of the finishing used during previous works of restore. The entrance portal and details of its decoration can be seen in Fig. 1.

Figure 1. San Nicholas Church (Bălinești) – entrance portal and details of the external decoration

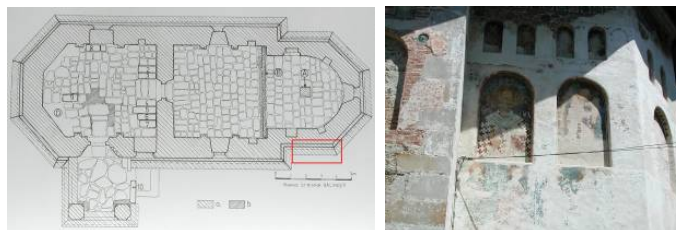
The IRT has been also carried out in the remaining frescoes, located in the south sector of the church. Figure 2 presents these frescoes. The area delineated in the plant of the construction indicates its localization.

Figure 2. San Nicholas Church (Bălinești) – outer frescoes evaluated by IRT

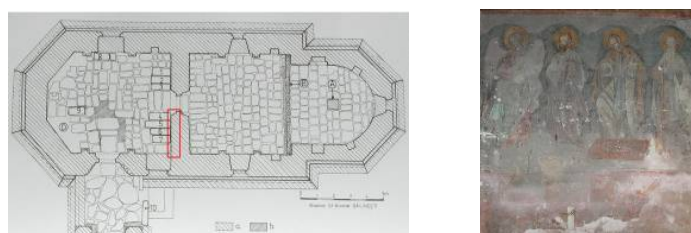
The diagnosis of the internal frescoes, using SLDV, has been concentrated in the entrance atrium. One of the evaluated areas is shown in Fig. 3 that also presents one of the studied frescoes.

Figure 3. San Nicholas Church (Bălinești) – fresco evaluated by SLDV

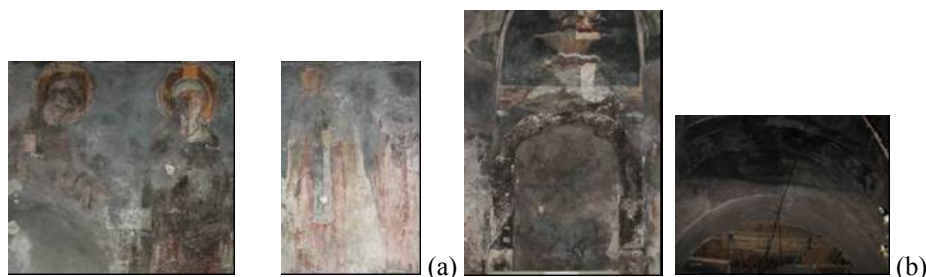
The presence of humidity damaged strongly the inner frescoes. To solve this problem, an effective restoration process was initiated in 2002. Part of the paintings located in the altar and in the aisle has been already restored. The vibrometric and thermographic tests have been concentrated in the internal area of the entrance atrium, not yet restored.

The SLDV has investigated detachments of the frescoes (some of them already visually perceptible). The IRT was used for the qualitative evaluation of structures and of non-visible structural elements. Figure 4 presents two frescoes evaluated by SLDV and two of the structures investigated by the implementation of the passive thermography.

Figure 4. Church of Popăuți Monastery (Botoșani) – frescoes evaluated by SLDV (a) and structures investigated by IRT (b)

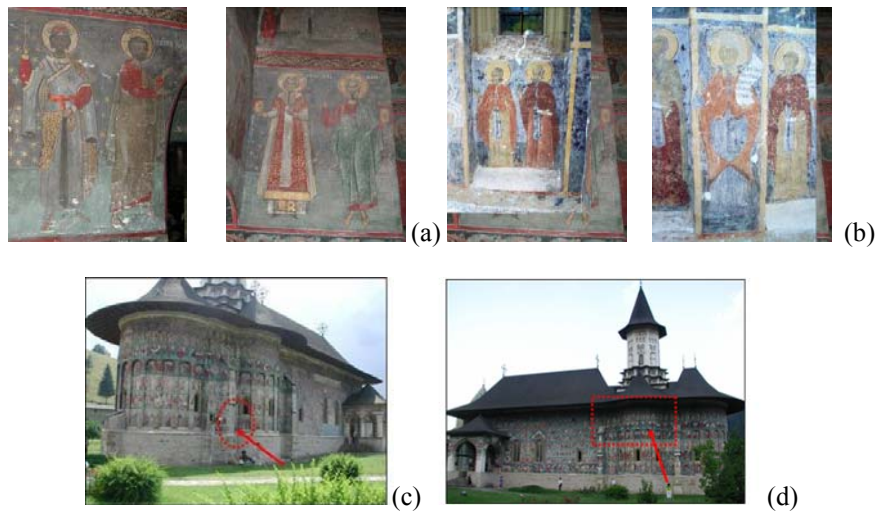
Figure 5 shows the frescoes evaluated by the SLDV and presents a general vision of the north and south walls, where are delineated the sectors in which the more relevant results obtained by the implementation of the passive thermography have been registered.

Figure 5. Church of Resurrection (Sucevița Monastery) – indoor frescoes evaluated by SLDV (a), outer frescoes evaluated by SLDV (b), area of the north wall evaluated by IRT (c), area of the south wall evaluated by IRT (d)
