EFFECT OF WATER AGING IN MECHANICAL PROPERTIES OF COMPOSITE MATERIAL FOR FILAMENT WINDING

Abstract *The filament winding process is used for the production of pipes of composite materials. A study of the influence of water and temperature on the mechanical properties of these materials is necessary due to their exposition to environmental humidity in operation. In the present work, the mechanical properties of composite materials of polymeric matrix of vinyl ester resin with reinforcement in the form of fiberglass roving, developed for pipe production by filament winding technique were determined through tensile tests. The composites were submitted to a hygrothermal treatment in order to evaluate the influence of water and temperature on modulus of elasticity, tensile strain, tensile strength and toughness. Additionally, a microstructural and fractographic study was carried out aiming a comparative evaluation of the microstructure and fracture surface of the developed material before and after the aging process. The results show that aging caused a drop in tensile strength, tensile strain and led to a marked increase in modulus of elasticity of the material. This can be explained

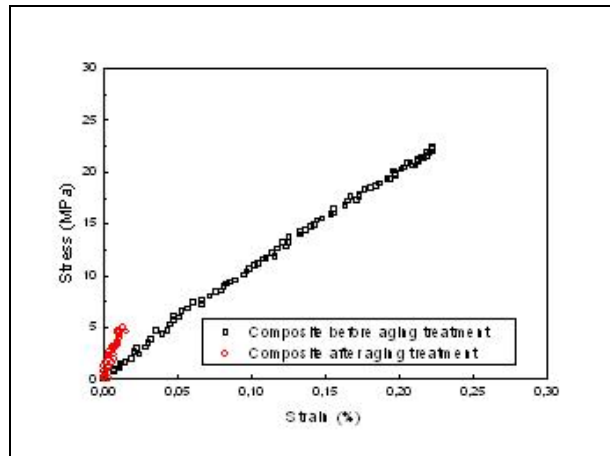
Figure 5 shows characteristic tensile curves of longitudinal samples of aged and unaged material and Fig. 6 shows the same for transverse samples. Table 1 and 2 show the corresponding average mechanical properties of aged and unaged materials, respectively. The properties evaluated were tensile modulus of elasticity (E), tensile strain (ϵ), tensile strength (σ_R) and, toughness.

Figure 6. Stress-strain curves of aged and unaged materials. Transverse samples.

The results show a marked fall of tensile strength and tensile strain and a considerable increase in modulus of elasticity of the material after the aging treatment, which is possibly related with post-cure of the resin, originated from the hydrothermal treatment of the material at 60°C. It was noticed that room temperature wasn't sufficient to the complete cure of composite material. Then, post-cure take place during the aging treatment by the application of higher temperature.

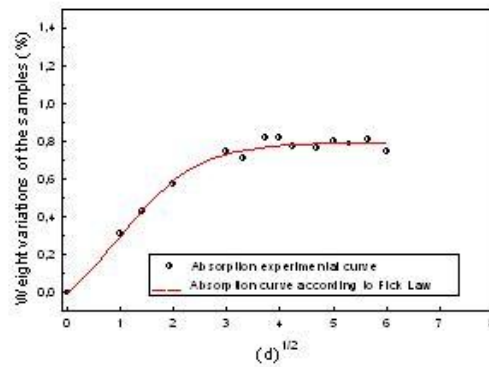
In terms of water absorption the composite material after aging for 36 days at 60°C presented a behavior similar to the one presenting the Fick's law, reaching saturation after 14 days of immersion and presenting maximum value of 0,82% absorption. Figure 7 illustrates experimental behavior and behavior according to Fick Law, allowing the comparative analysis of the absorption process.

Figure 7. Weight change of specimens as a function of time of aging. Solid curve is theoretical.
