Performance of Different Coatings on High Speed Steel Broaches

Key Words: broaching, PVD coating, powder metallurgy high speed steel.

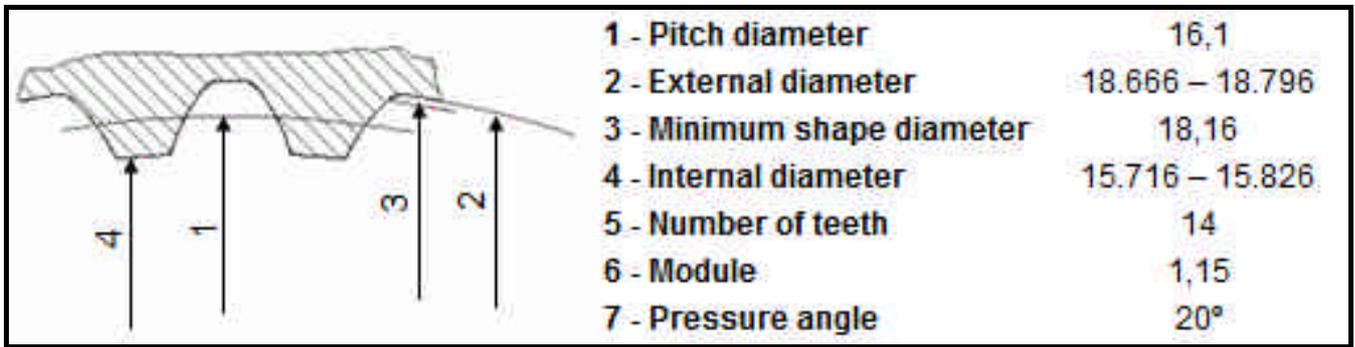
For these experiments, the clutch disc component known as a clutch hub was used as workpiece. The clutch hub is manufactured with DIN C45 steel at 23 – 28 HRC hardness. Figure 1 shows the dimensions of the internal profile, used in the clutch hub.

Figure 1: Internal profile construction dimensions

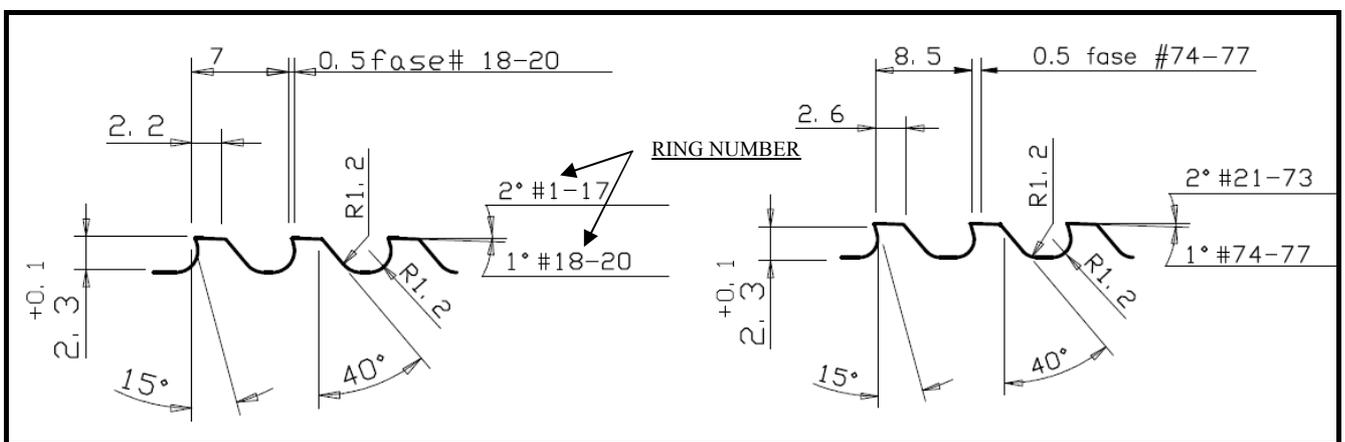
The tests were carried out with special broaches, which were manufactured according to a pre-defined profile. Broach length was 950 mm, with 617.5 mm used by the cutting teeth, that are formed by 77 rings. Figure 2 details some the dimensions of the broach's teeth.

Figure 2: Details of the dimensions of the broach teeth.

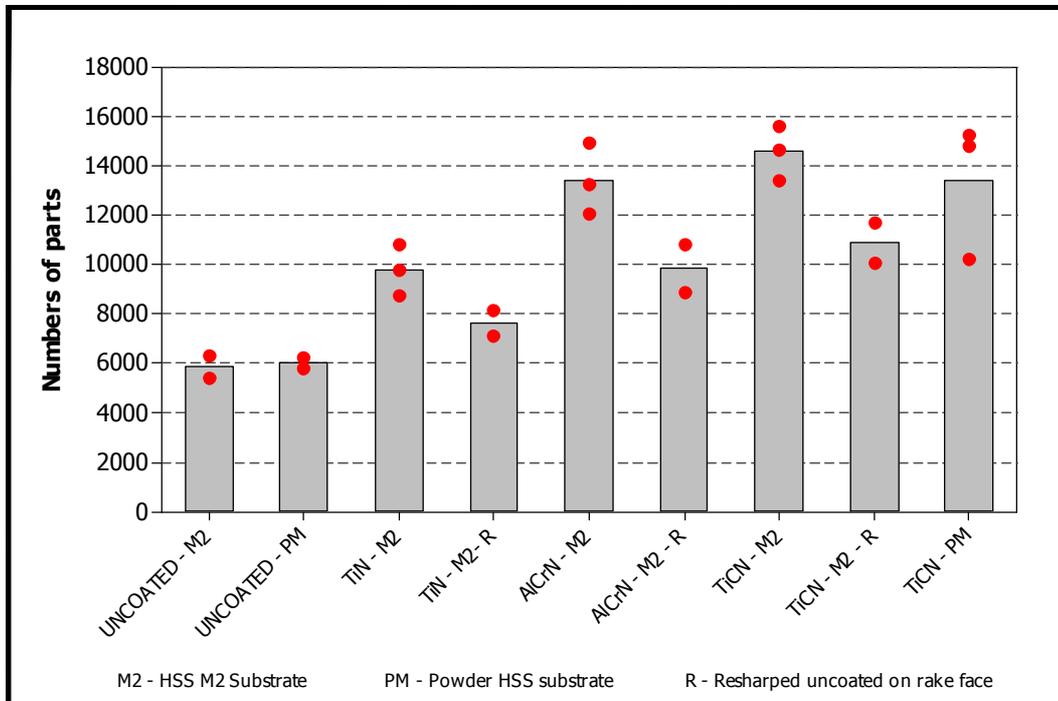
In Fig. 3, the dots represent the values obtained for each test, and the columns represent the average of values. Analyzing the results obtained for uncoated broaches, one can notice that the difference between the averages is rather low, below 3%. Therefore, it is not possible to assure that the sintered high-speed steel broach outperforms the M2 high-speed steel broach regarding the quantity of the broached parts.

The coated broaches significantly outperformed the uncoated broaches. Even the broach that received the TiN coating – which showed the poorest performance amongst the coated broaches – had an average result of 68% higher when compared with the M2 broaches, and 63% higher than the sintered broach, which were both uncoated. When this

Figure 3: Coated and uncoated broches

comparison is made between tools with AlCrN and TiCN coating, rather than TiN coating, the difference increases largely (to 130% and 123% for broaches with AlCrN, and 149% and 142% for broaches with TiCN coating). This is a result of the increased surface hardness of the tools provided by the use of these coatings.

The resharpened coated broaches (and so, uncoated on the rake face, which allowed the chippings to have direct contact with the broach substrate)— demonstrated a shorter tool life compared with the full coated tools, for all types of coatings. On average, the broach tool life decreased by 25%. However, when we compare with the broaches which did not receive coatings, the resharpened broaches which maintained their coating on the clearance face, showed an increase in the number of broached parts per tool life of approximately 30% for TiN broaches, 68% for AlCrN and 86% for TiCN broaches. The test showed that the coating improves the performance of a broach, not only during the first tool life when it has its surface fully coated, but also when the broach is re-sharpened and not recoated. A good reason for the outstanding performance of broaches uncoated on rake face, as shown later, is the absence of crater wear which could cause the embrittlement of the cutting edge, causing further wear, since the coating still remains on the clearance surface – the area of friction with the part during broaching.

The powder steel substrate broach with TiCN coating showed a poorer performance than the M2 high-speed steel substrate broach, when average values are compared. However, through a hypothesis test, it is not possible to confirm statistically that there is a difference between the two types of substrate. A possible explanation for the poorer performance of the sintered high-speed steel, it might be that machining occurs at low cutting speed (8m/min) generating temperatures below sintered steel temperature resistance limits, thus matching the M2 high-speed steel, under equaled conditions.

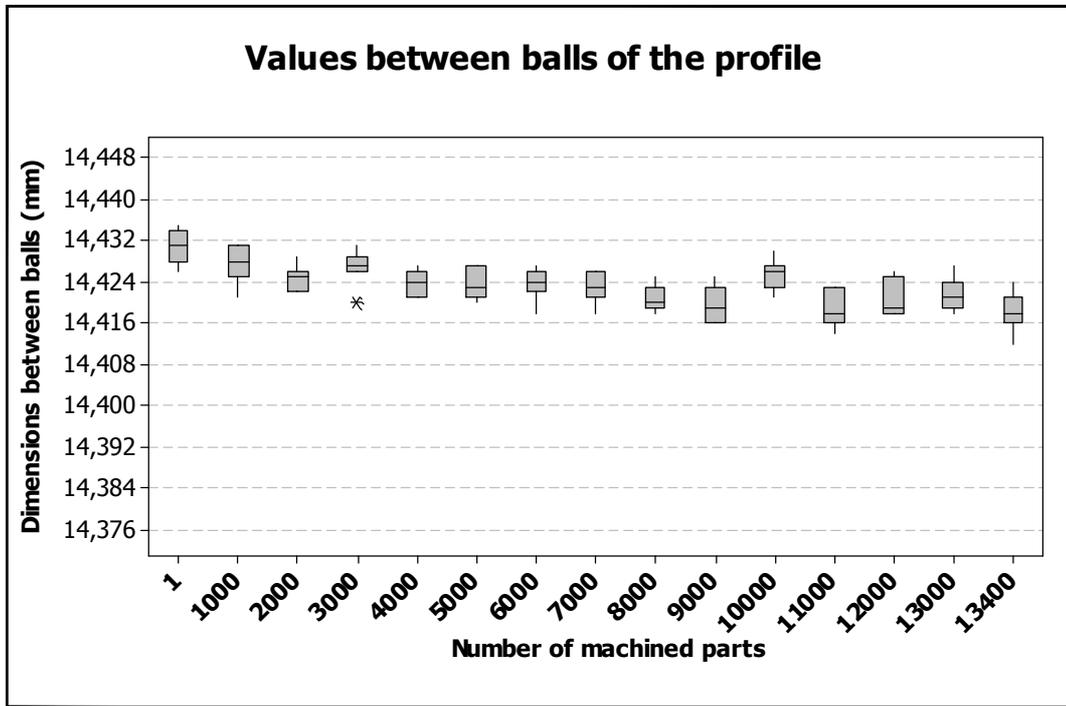
Trying to verify the behavior of the dimension of the internal profile during the life of the broaches, the internal profile has been measured during the third tool life test of TiCN coated, with M2 high-speed steel broaches. The specification of values between balls of the internal profile must range between 14.381 and 14.442mm. Figure 4 shows the values found in measurements throughout the test.

The measurement between balls is equivalent to the distance between two clearances of the internal profile which are positioned at a 180° angled distance. As the internal profile of the part contains 14 clearances, each measuring generated seven values for each part. Figure 4 shows the dimensional variation of the internal profile for each pair of clearances and in distinct parts during the life of the broach. The variation found in values of the internal profile in the same part is caused mainly by the dimensional variation of the broach. This dimension did not show significant variations during the tool life. The same occurred when the dimensional variation between parts was analyzed, which remained small. The likely reason for such small variations is the slight diameter reduction of the broach when the clearance surface wear reaches the end of the tool life criterion. A 0.15mm wear on the clearance surface of the broach causes a reduction of the broach tooth of only 0.005mm, consequently 0.01mm of the broach diameter.

Figure 4: Values between balls of the profile

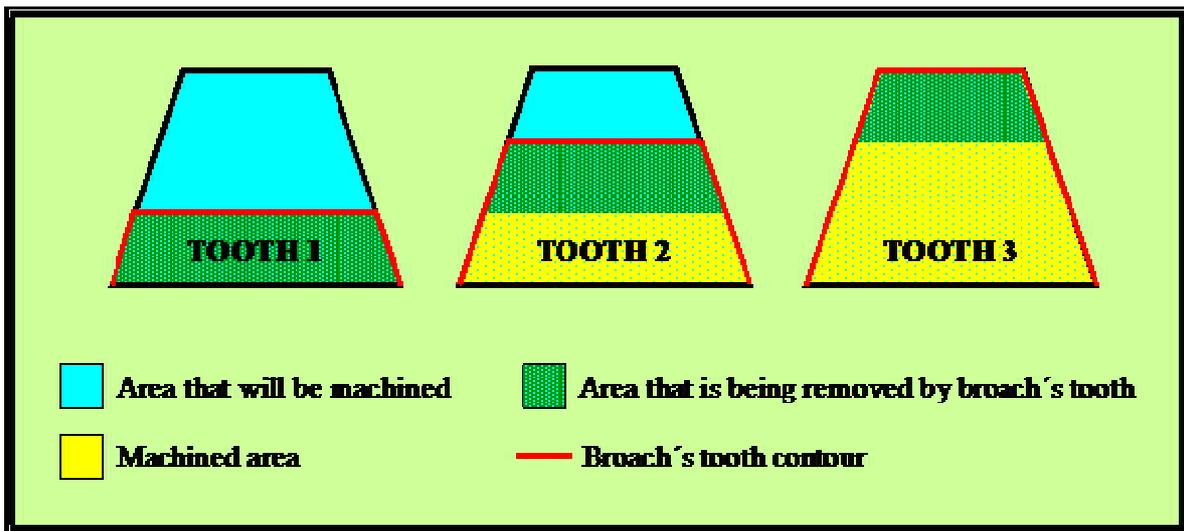
Another possible explanation is that during broaching each tooth machines at the height related to each tooth's course, without altering the height machined by the prior tooth. According to the scheme shown in Fig. 5, while a part is machined, broach tooth 2 does not remove material from the area previously machined by tooth 1, and tooth 3 behaves likewise

Figure 5: Machining of the teeth

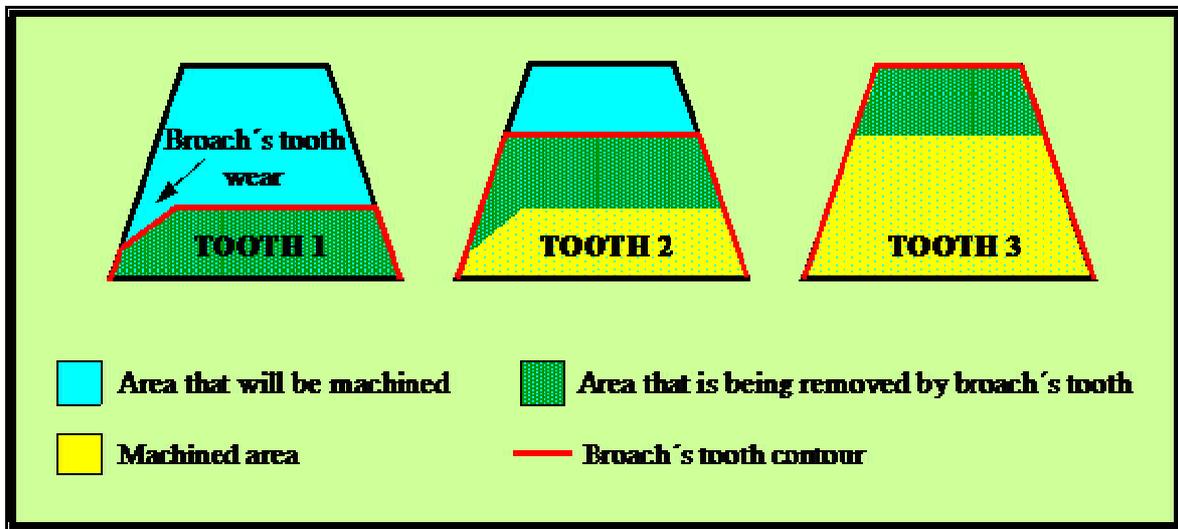
As the cutting edge and, subsequently, the corner of the tooth wear, the width of the area machined in this region is reduced. Due to the wear, the area of the broach's tooth – which earlier simply drove past the clearance that had been previously machined by the prior tooth without removing further material – now it starts to remove material from the part's clearance which had not yet been removed by the prior tooth. This will continue to happen to the other teeth of the broach, contributing to a small dimensional variation of the profile. Figure 6 shows what happens in machining, in the presence of wear.

Figure 6: Machining of teeth with wear.

While machining the part, in order to stop the broach's tooth from suffering friction of its side edge against the area of the part that has already been machined by the previous tooth, there is a tooth width reduction of 0.036mm from the first to the last tooth that machines the internal profile.

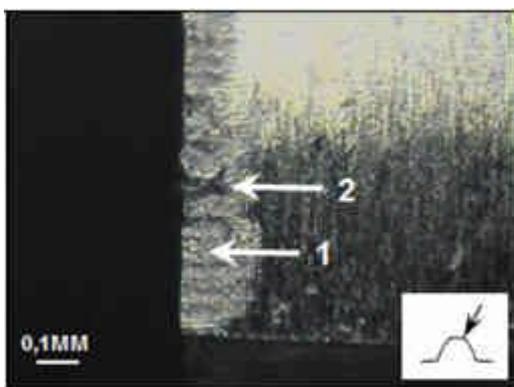
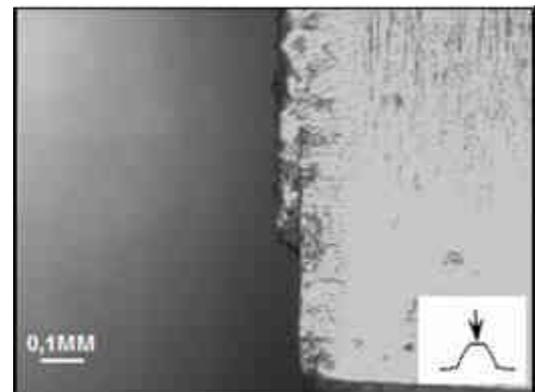
Figure 7a, magnified to 202 times, shows the most severely worn region of the cutting edge of a tooth of a M2 high-speed steel broach. The same figure shows point 1 identifying abrasive wear, generated by the contact of the clearance surface of the tool with the part. Point 2 identifies that material has been removed from the tool, most likely caused by adhesive wear. Figure 8a shows severe abrasive wear on the broach's tooth corner, at the intersection of the lateral surface and the top of the tooth. This is mainly due to the embrittlement of this area, given that these two surfaces meet at a sharp corner. When measuring the wear, it has become evident that the area of the corner of the tooth is the most severely affected. In Fig. 7b and 8b, a build up cutting edge appears and point 1 of Fig. 8b shows the removal of material from the cutting edge, most likely caused by the breaking of the build up cutting edge during broaching.

Figure 7: M2 high-speed steel broaches.

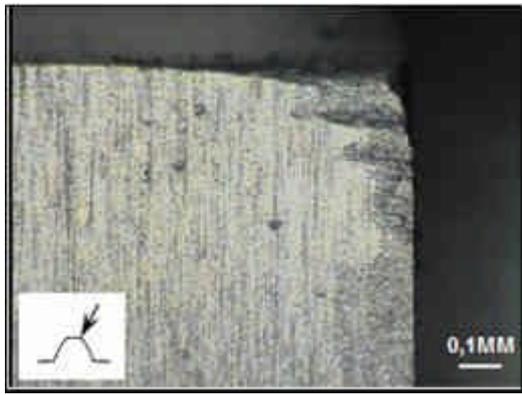
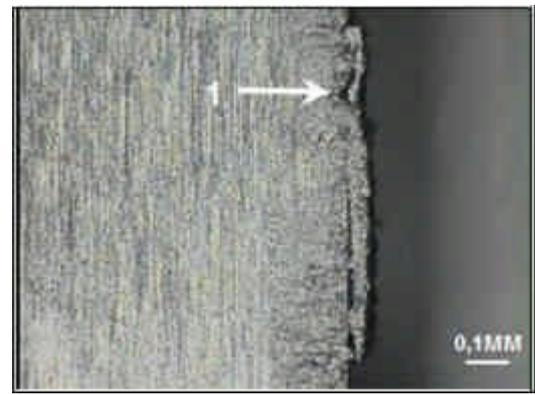
Figure 8: Sintered high-speed steel broaches.

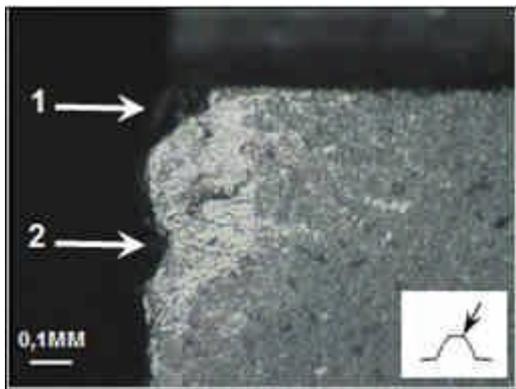
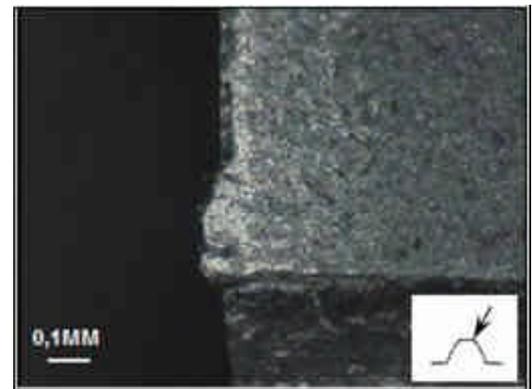
The types of wear found after experiments with M2 high-speed steel broaches coated with TiN, AlCrN and TiCN were nearly the same as those found in experiments with uncoated broaches. Figures 9a and 9b show the presence of part material adhered to the cutting edge. Points 1 and 2 of Fig. 9a show the removal of material from the tool, most likely caused by adherence wear processes. Figure 10b and 11b again show that there have been part material adherence to the tool, with the appearance of a build up cutting edge in 10b, and a severe wear on the corner of the broach's tooth in 11b. The same might have occurred to the tooth shown in Fig. 10a, where drawn out material from the cutting edge can be seen in various points, as well as a severe wear on the corner of the broach's tooth. In Fig. 11a, we can notice the occurrence of abrasive wear, and because the wear did not remove all the TiCN coating from the broach's tooth, we cannot see part material adhered to the tool.

Figure 9: Broaches with AlCrN coating

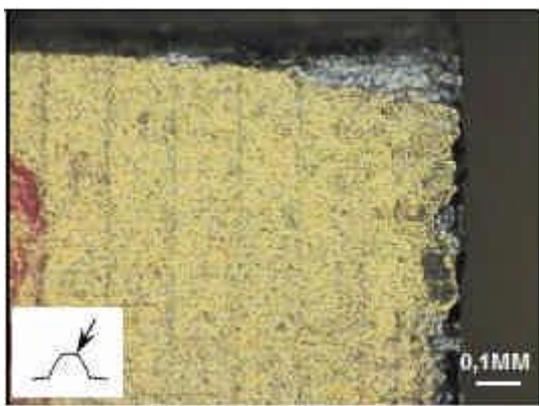
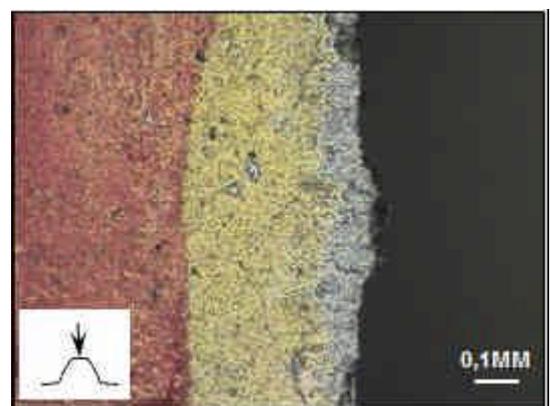
Figure 10: Broaches with TiN coating.

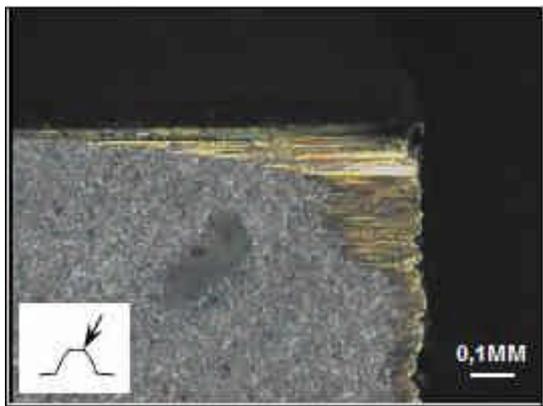
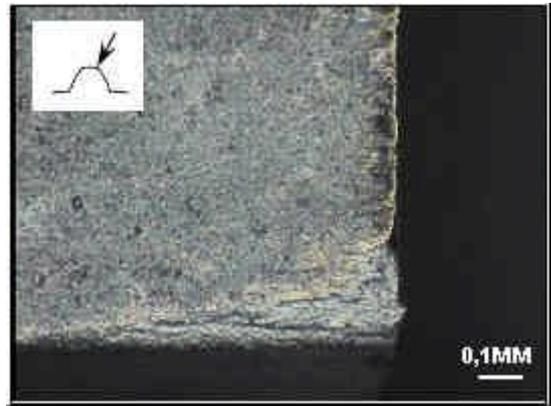
Figure 11: Broaches with TiCN coating.

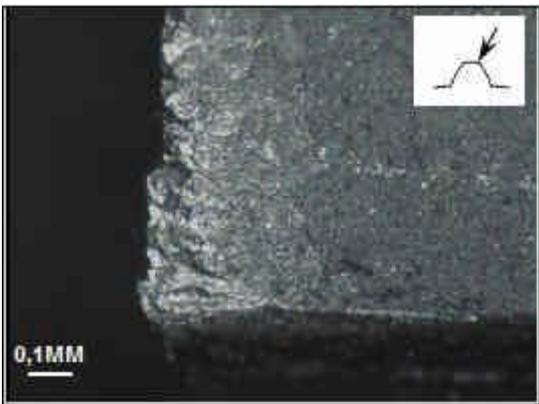
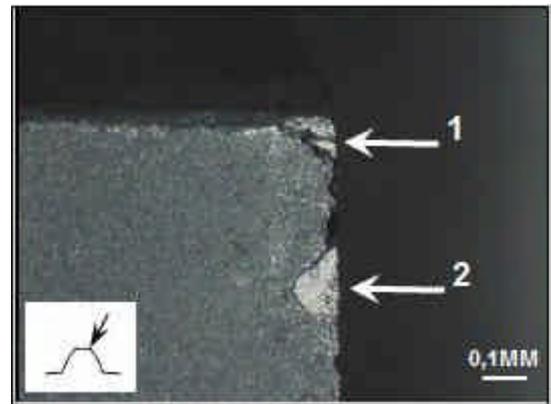
Resharpener tools that had not been retreated with a new coating, as shown in Fig. 12a and 14a, show the adherence of part material on the tool, and the appearance of a build up cutting edge. However, in Fig. 13b, 14a and 14b, point 1 clearly identifies abrasive wear of the cutting edge. Figures 12b, 13b and 14b, show in point 2, the presence of various points of frittering/micro-chip, which probably happened because of the absence of coating on the rake face of the broach. This often leads to a greater incidence of adherence of part material on the cutting edge and the appearance of a build up cutting edge, resulting in the deterioration of the edge. Another possible reason is the displacement of the coating on the clearance surface of the tooth, as seen in point 1 of Fig. 12b and 13a, allowing direct contact of the part material with the broach's substrate on the tooth's clearance surface, rapidly increasing wear on these regions, since the substrate offers a significantly lower resistance than the coating.

Figure 12: Broaches with AlCrN uncoated on rake face.

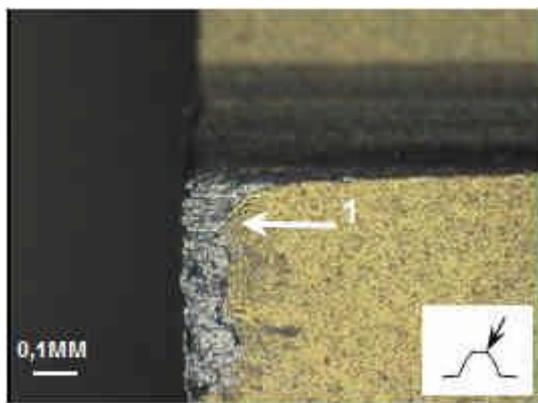
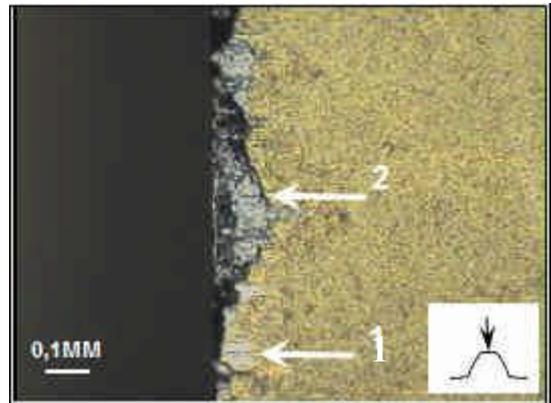
Figure 13: Broaches with TiN uncoated on rake face

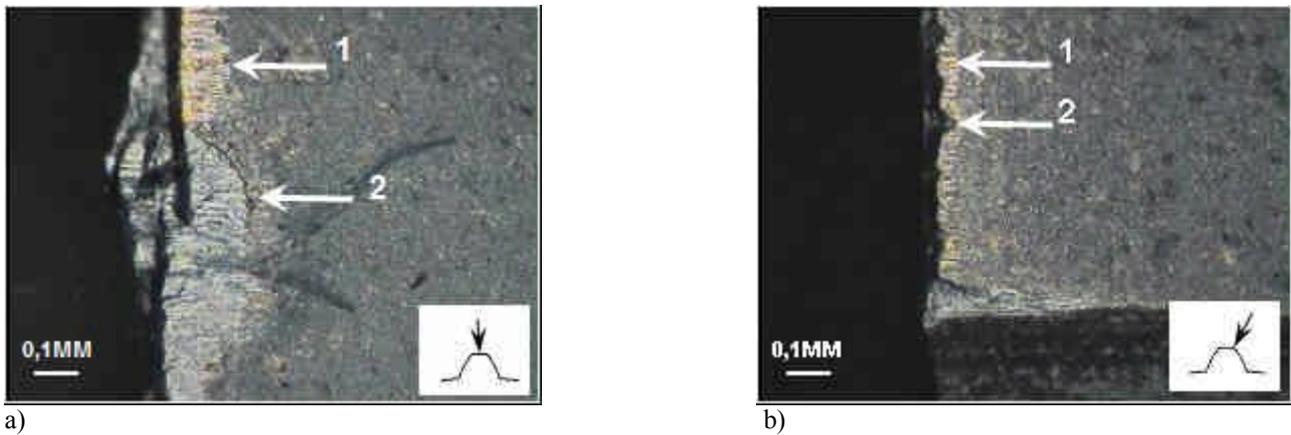
Figure 14: Broaches with TiCN uncoated on rake face

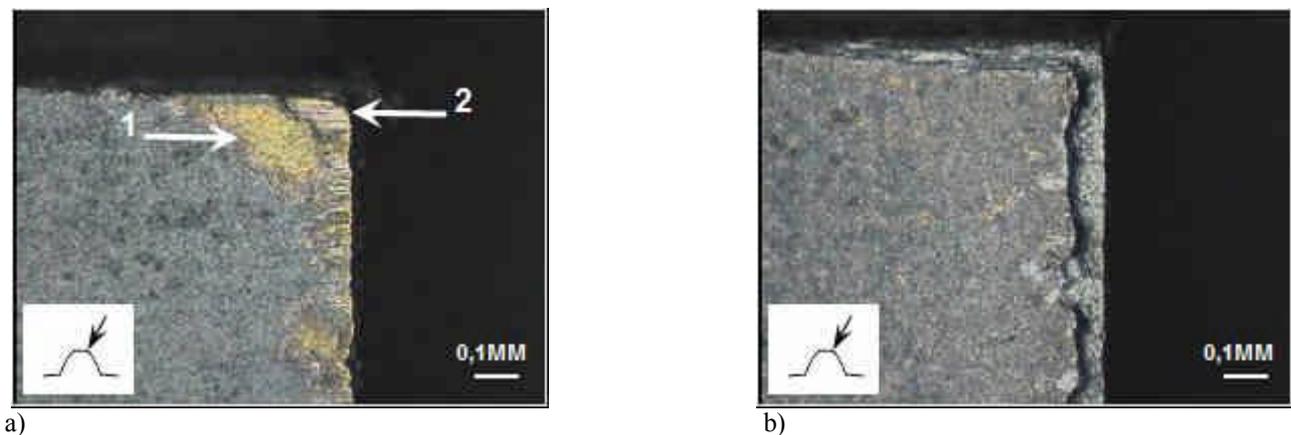
For TiCN coated, powder high-speed steel broaches, point 1 of Fig. 15a shows the displacement of the coating. In point 2, one can notice the occurrence of abrasive wear, characterized by scratches parallel to the cutting direction. In Fig. 15b one can see that the broach's material has been drawn out, probably due to adherence of part material. It is also possible to notice that the tooth's corner presented a more severe wear. Apparently, there have been both adherence and abrasive wear.

Figure 15: Broach with TiCN coating.
